# TECHNICAL REPORT

## PENITENTIARY ABLUTIONS AREA 2016 ARCHAEOLOGICAL INVESTIGATIONS

PAHSMA Archaeological Project PA2016-01

### PORT ARTHUR HISTORIC SITE, TASMANIA

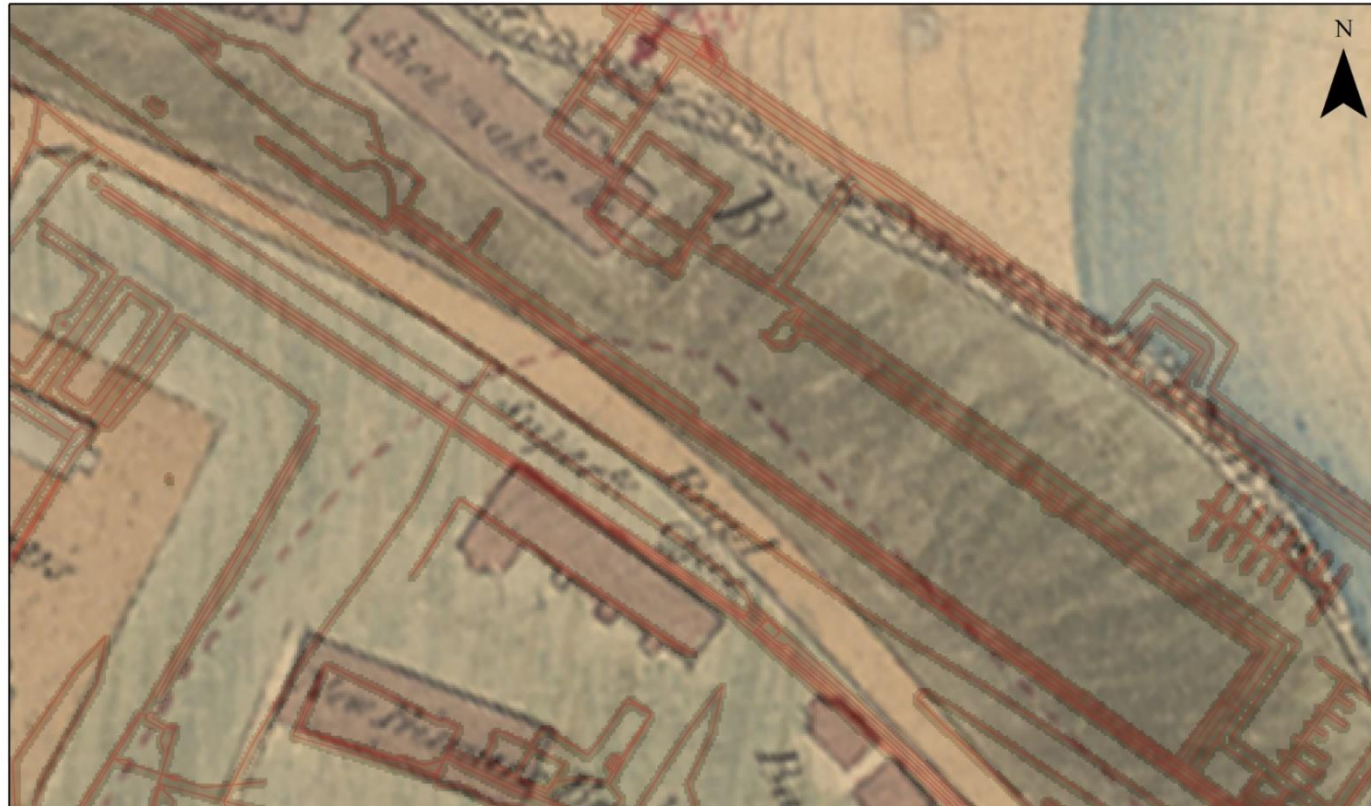
**PENITENTIARY PRECINCT 2016 - Ablutions area map regression**  
Plan - 1833

Figure 4: Detail of 1833 plan (J.H. Hughes, 'The settlement at Port Arthur', 1833, PAHSMA Collection)

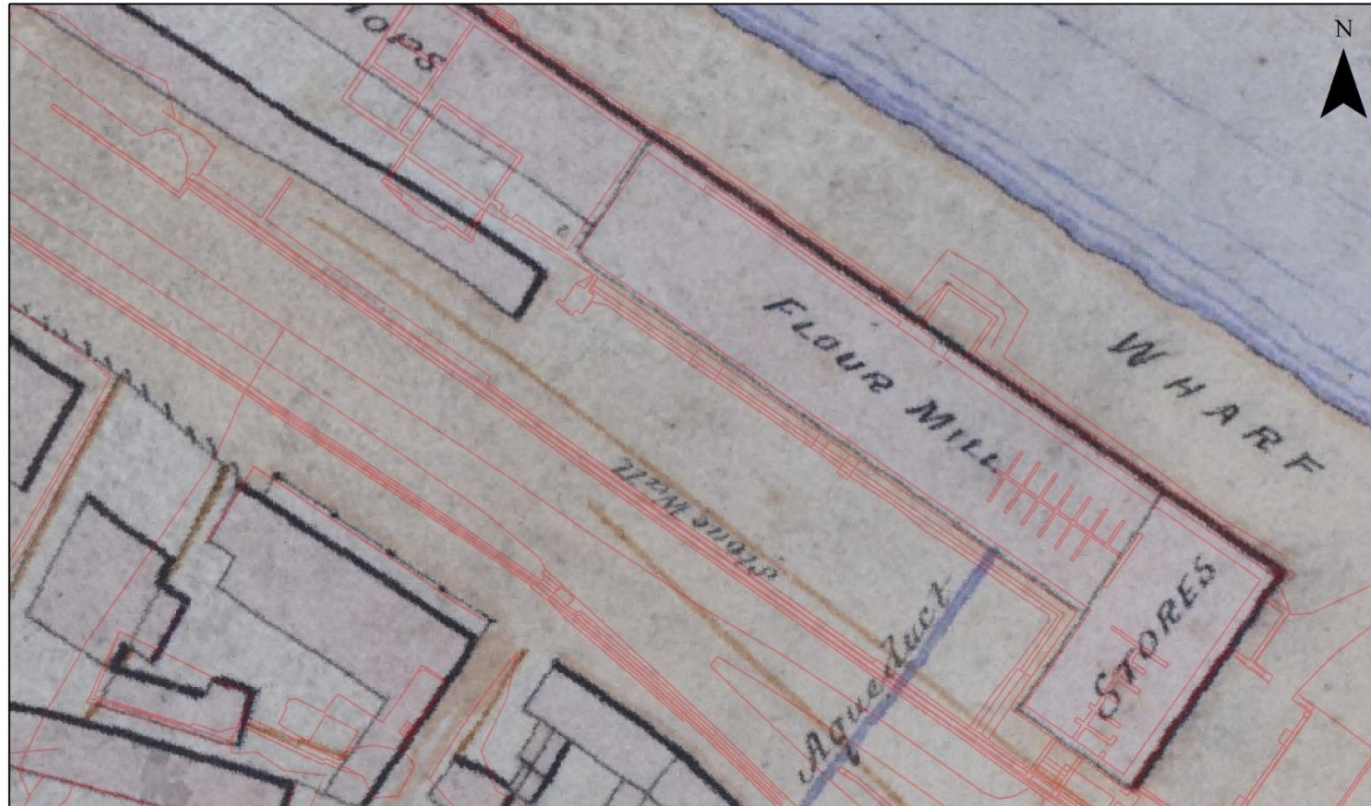
**PENITENTIARY PRECINCT 2016 - Ablutions area map regression**  
Plan - 1846

Figure 11: Detail of 1846 site plan (J.R. Hurst, 'Plan of the Penal Settlement at Port Arthur, VDL', 1846, PAHSMA Collection)

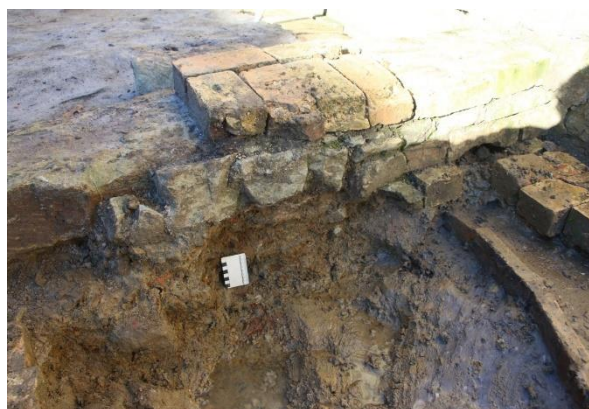
**Figure 30: Day room, showing footing [0019] on top of natural stratigraphy (0814)** (facing south-south-east, PA2016\_01\_1716)

bedrock, natural stratigraphy (0814) was also encountered toward the south-eastern extent of the day room (Figure 30), as well as north of footing [0161] where there was a concentration of rounded dolerite in a silty clay matrix (0305) (Figure 31). This latter deposit had a similar composition and stratigraphic sequence to clay and dolerite deposits located in the northern extent of the east yard.

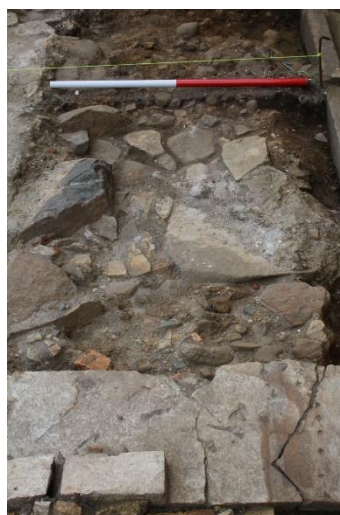
**Figure 31: Day room, showing bedrock and (0305) clay at northern end of area** (facing north-west, PA2016\_01\_0749)

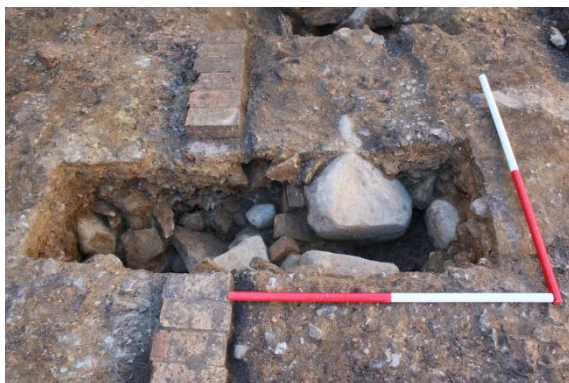
**Figure 32: Day room, DRS 1 (facing north-west, PA2016\_01\_0961)**

In DRS 2, a cut, [0555], was clearly visible, but the edges of it were more difficult to discern in DRS 1 (Figure 32 and Figure 33). At the base of the cut was [0558], a linear arrangement of dolerite, sandstone and brick running north-west to south-east through both slots. Above this were fills (0559) and (0563). Cut [0555] was also located within DRS 4, which was placed to abut day room footing [0019]. This found that [0555] abutted the footing and was filled with up to 0.16m of (0556) fill, overlying a linear alignment of brick and dolerite [0558] running north-west to south-east through the slot, as well as fill (0559). Feature [0558] aligned with a deliberately shaped void running under footing [0019], capped with a piece of flat iron (Figure 34).

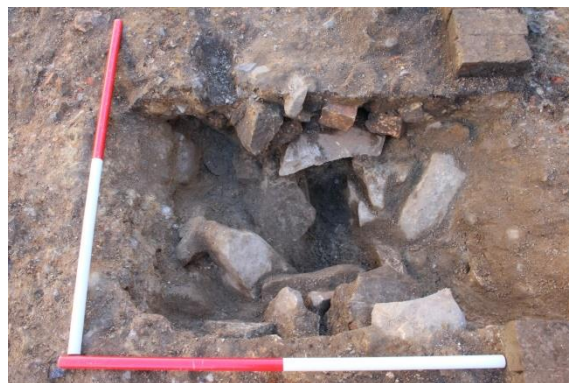
**Figure 33: Day room, DRS 2 (facing north-west, PA2016\_01\_0963)**

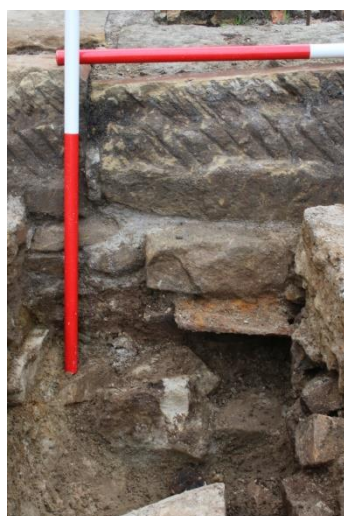
**Figure 34: Day room, DRS 4 (facing south-east, PA2016\_01\_0940)**

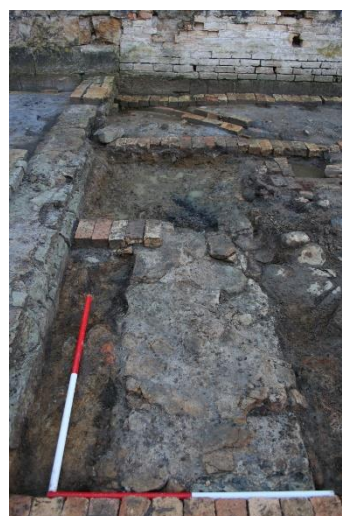
**Figure 35: Day room, showing footing [0540] (facing south-west, PA2016\_01\_1691)**

Running parallel with footing [0019] was feature [0540]. Formed from roughly-dressed sandstone bonded with a shell lime mortar it was offset 0.50 – 0.75m from [0019] and ran north-east to south-east through the eastern extent of the day room (Figure 35). At least 3.00m of it remained *in situ*, up to 0.75m wide. The feature was set in cut [0539]. This cut traced a similar alignment, although at least 5.00m of it was visible. It had been made into the clay layers (0561)/(0562). A section of the cut was investigated in DRS 3, which showed that [0540] had been robbed out and the resulting void filled with (0541) (Figure 36). The cut in this section had been made into bedrock, which cropped out within 0.05m of the clay surface at this point. The cut in the bedrock was square-sided and flat-based. The northern continuation of [0539] and [0540] was not traced, though the high concentration of sandstone rubble below (0311), in and around cut [0273] and deposit (0305) suggested the possibility that [0540] had continued to this point and been truncated by the laying of the drain and day room elements. The southern extent of the alignment was investigated by DRS 5, finding that [0540] had been robbed [0544] and the resultant space filled by (0788). Drain elements associated with Phase I had also resulted in the truncation of [0540] in this area.

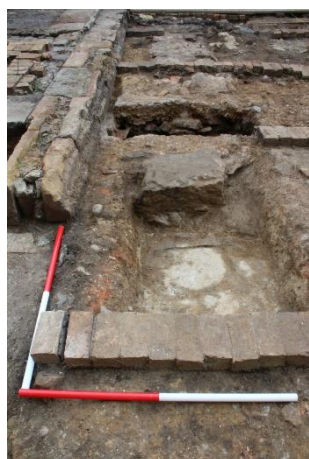
**Figure 36: Day room, showing footing [0540] and construction cut in bedrock (facing south-west, PA2016\_01\_0935)**

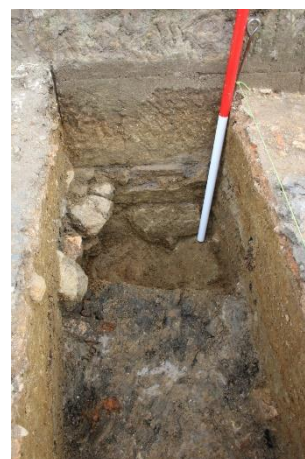
**Figure 37: West yard, YS 1, showing (0501) and bedrock (facing south-west, PA2016\_01\_0849)**

In the west yard, dolerite bedrock was only encountered in the southern extent, where a slot YS (yard slot) 1 was cut abutting the Champ Street retaining wall (Figure 37). The section of bedrock was 0.60m below the level of the clay, at 1.30m AHD. No bedrock was located anywhere else within the yard, although natural clay with heavily weathered dolerite was encountered in the northern extent of the yard. These clays, (0735) and (0736), were cohesive, inclusion-free deposits, other than weathered doleritic veining, and were found in all three of the slots excavated through the drainage sumps.

In YS 1 against the Champ Street retaining wall, as well as wall slot (WS) 1, a dark clay silt (0501) with charcoal, dolerite and brick inclusions was encountered (Figure 37). In the former slot it was situated at 1.40m AHD (0.20m above the level of the bedrock) and 1.27m AHD in WS1.

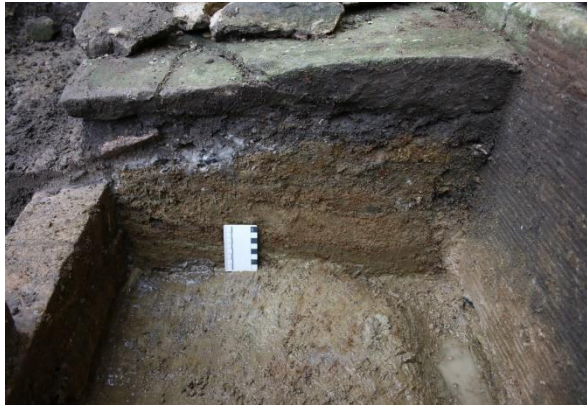
**Figure 38: West yard, SS 1, showing natural stratigraphy (0735)/(0736) (facing north-west, PA2016\_01\_1589)**

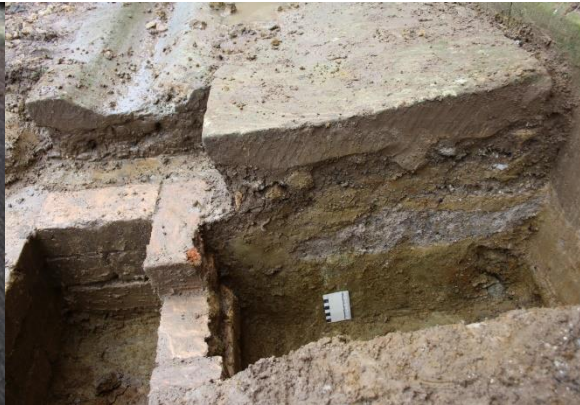
**Figure 39: West yard, SS 2, showing natural stratigraphy (0735)/(0736) (facing north-west, PA2016\_01\_1582)**

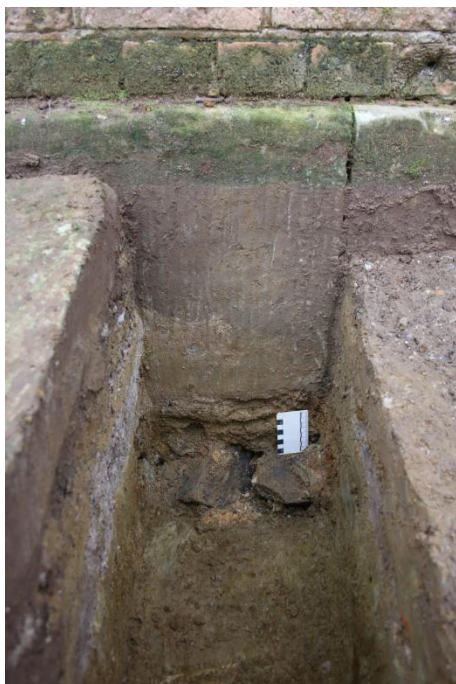
**Figure 40: West yard, SS 2, showing Penitentiary footings [0002] (facing north-east, PA2016\_01\_1584)**

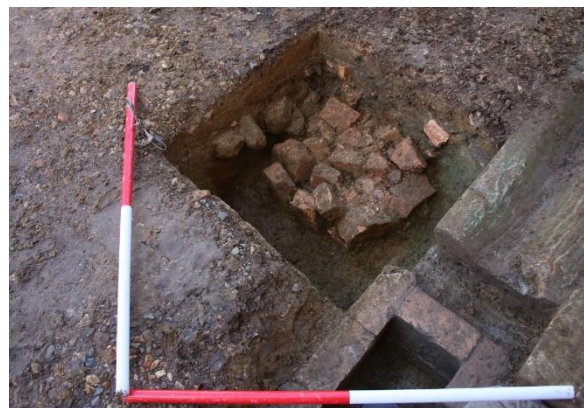
**Figure 41: West yard, SS 2, cut [0742] containing brick debris (0743) (facing west, PA2016\_01\_1609)**

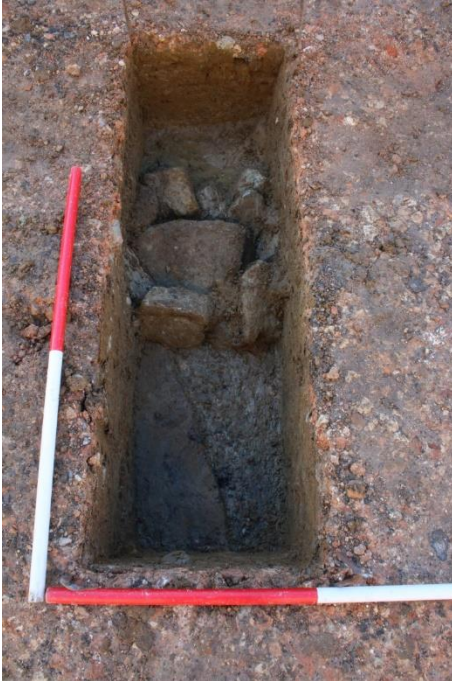
**Figure 42:** West yard, DS 6, drain [0554] (facing north-east, PA2016\_01\_1666)

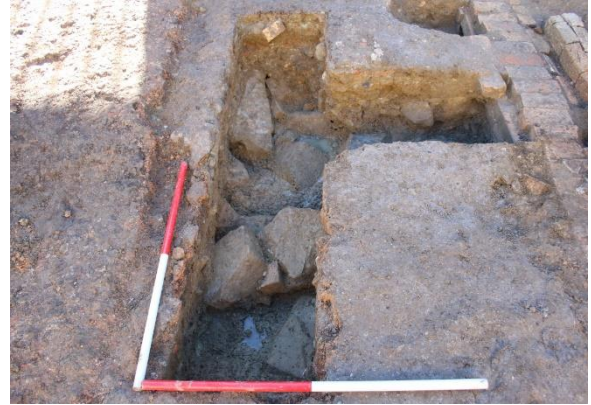
**Figure 43:** West yard, DS 7, drain [0554] (facing north-east, PA2016\_01\_1698)

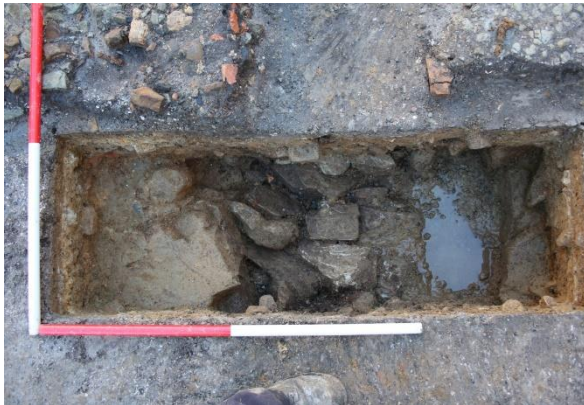
**Figure 44:** East yard, DS 5, showing drain [0753] cut into bedrock (facing north-west, PA2016\_01\_1702)

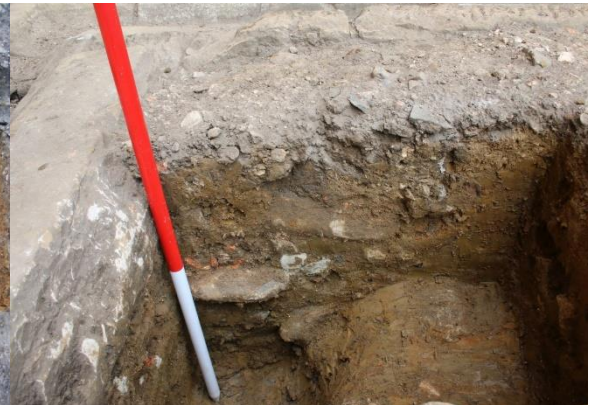
**Figure 45:** East yard, SS 5, natural stratigraphy (0811)-(0813) (facing south-east, PA2016\_01\_0527)

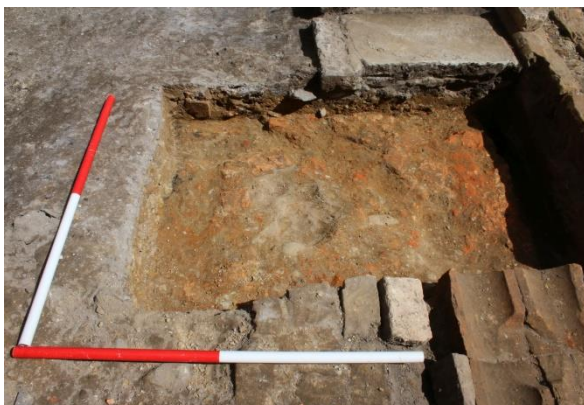
**Figure 46:** East yard, YS 3, deposit (0415) underlying (0414) (facing south-west, PA2016\_01\_0756)

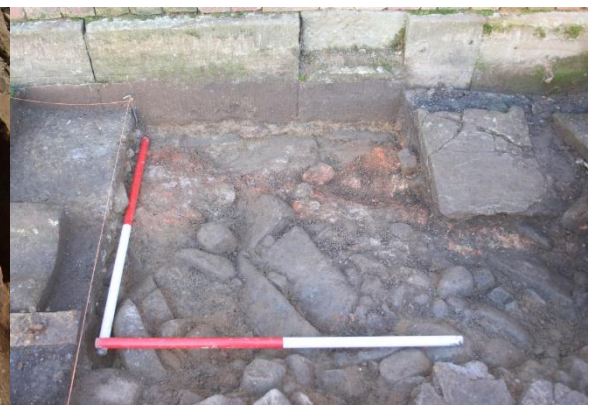
**Figure 47:** East yard, YS 4, showing outcropping bedrock, (0305) clay and brick (0793) (facing north-east, PA2016\_01\_1706)

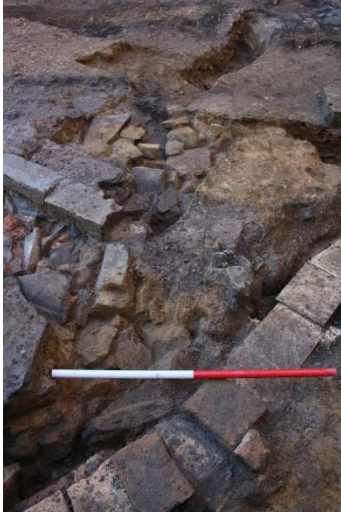
**Figure 48:** East yard, YS 8, drain [0757] within rubble (0567) (facing north, PA2016\_01\_1719)

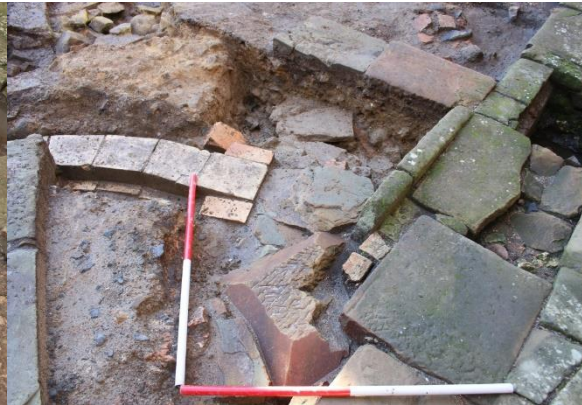
**Figure 51:** East yard, DS 4, showing eastern termination of [0753] (facing north, PA2016\_01\_1721)

a more curvilinear path across a portion of the yard. It contained feature [0268], an enclosed drain formed from brick tile spoon drains with brick spacers placed between. This feature was evidently a continuation of the truncated drain feature [0245] located within the day room (see above). The drain was covered by redeposited clay fills (0269)/(0270) and was at least 0.30m deep. Toward its south-eastern end, the drain turned easterly, cutting through footing [0324], before terminating at drain [0753] (Figure 51). The drain fell from 1.75m AHD at its north-western end, to 1.45m AHD where it met [0735].

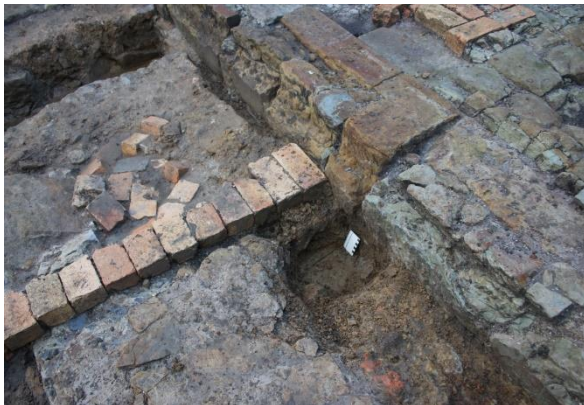
**Figure 52:** Day room, showing depth of footing [0019] (facing east-north-east, PA2016\_01\_1735)

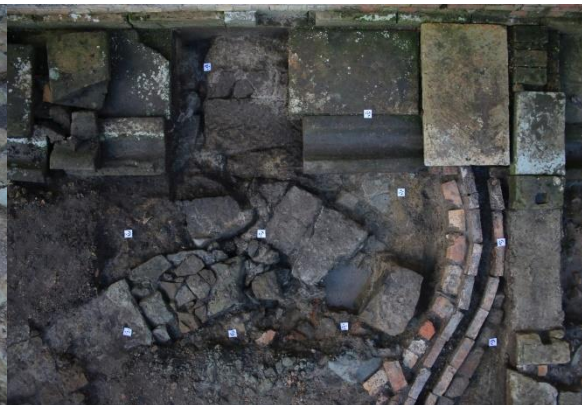
**Figure 53:** West yard, showing portal footing [0764] and [0802] (facing north-east, PA2016\_01\_1892)

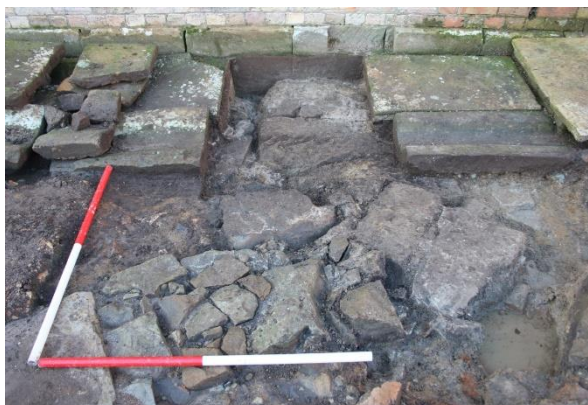
**Figure 54:** West yard, showing portal footing [0764] and [0802] (facing north-east, PA2016\_01\_1728)

of squared and dressed sandstone in a shell lime mortar [0802] was present north-east of [0764], below flagging [0003] and drainage [0004] (see below) (Figure 54).

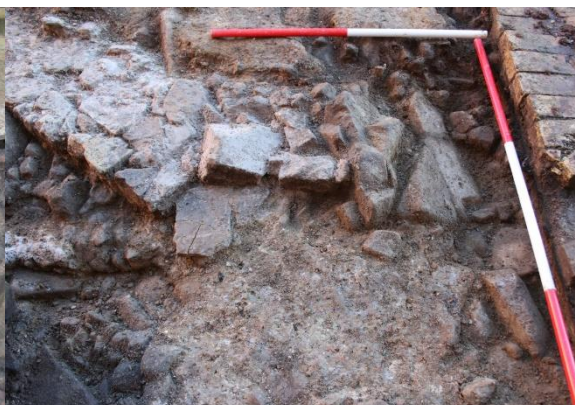
**Figure 55:** West yard, YS 4, showing bedrock and disturbed portal footing [0819] (facing south-west, PA2016\_01\_1688)

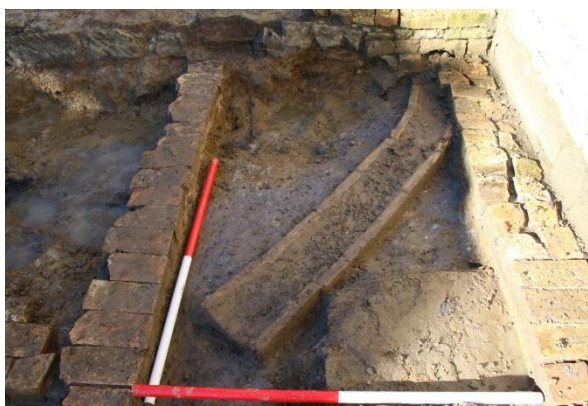
**Figure 56:** Day room, DRS 5, showing drain [0246] exiting under footing [0019] (facing south-east, PA2016\_01\_1714)

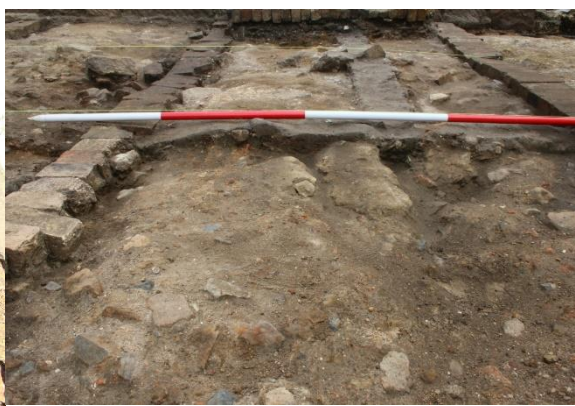
**Figure 57:** Day room, detail of (0064) clay interface (facing north-west, PA2016\_01\_0740)

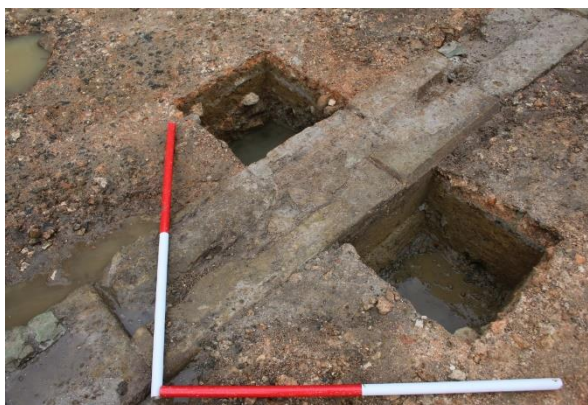
**Figure 58:** West yard, WS 1, showing depth of footing [0326] (facing west, PA2016\_01\_1528)

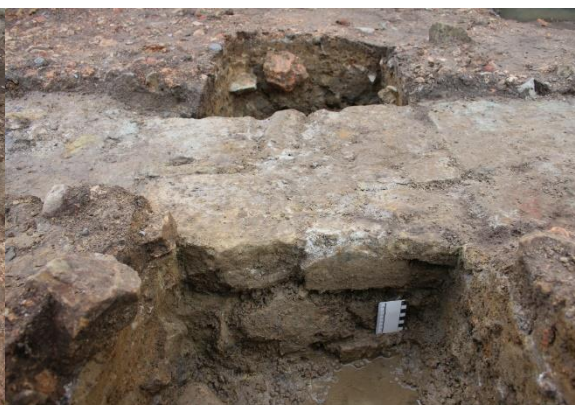
**Figure 59:** West yard, WS 2, showing depth of footing [0326] (facing north, PA2016\_01\_1502)

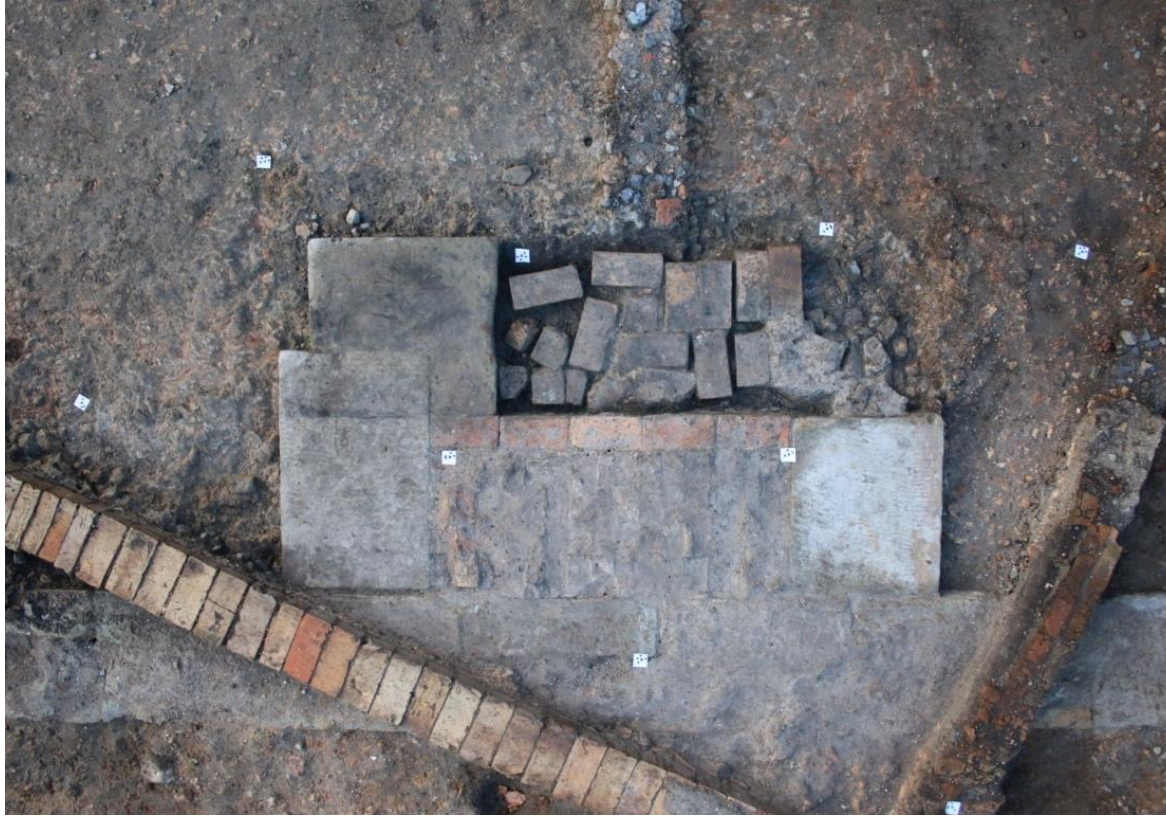
Figure 60: West yard, feature [0636] situated on north side of footing [0326] (facing north, PA2016\_01\_1287)

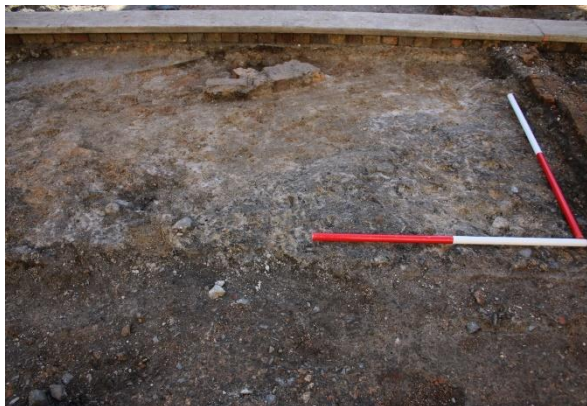
Figure 61: West yard, compact lime mortar (0600) and *in situ* brick [0810] south side of footing [0326] (facing north-east, PA2016\_01\_1136)

On the other side of [0326] is a series of deposits likely related to the removal of a feature from this area. Deposit (0600) was a compact mortar and rubble deposit up to 0.10m thick directly overlying (0332) and (0644). This was situated in correlation with (0599), a mortar, silt and charcoal deposit, and (0598), a deposit of sandstone rubble. A deposit of shell lime mortar (0577) was also situated in association with the removed footing. As on the northern side of [0326], these deposits were capped by compact mortar (0510), with a thin deposit of charcoal-rich silt (0511) extending to the south (Figure 61).

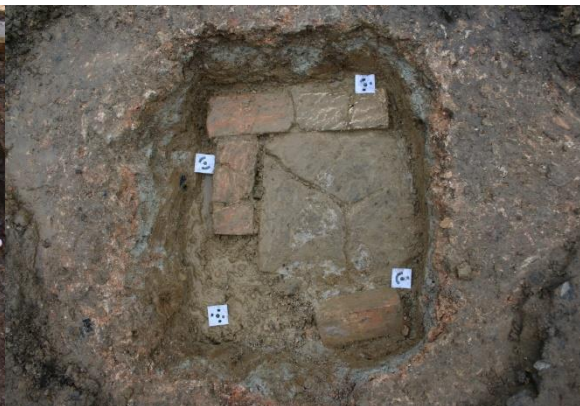
Figure 62: West yard, posthole cut [0609] showing [0624] features at base (facing north-east, PA2016\_01\_1229)

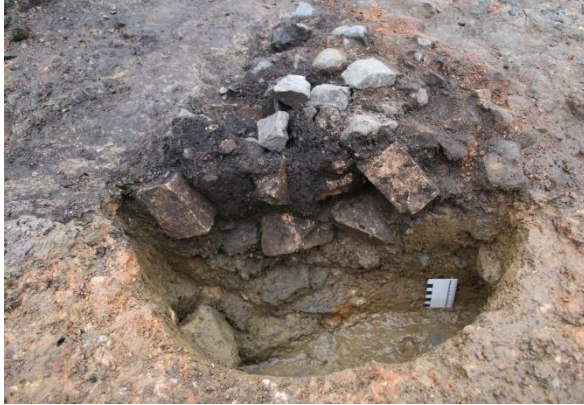
**Figure 63: West yard, posthole cut [0612] (facing north, PA2016\_01\_1223)**

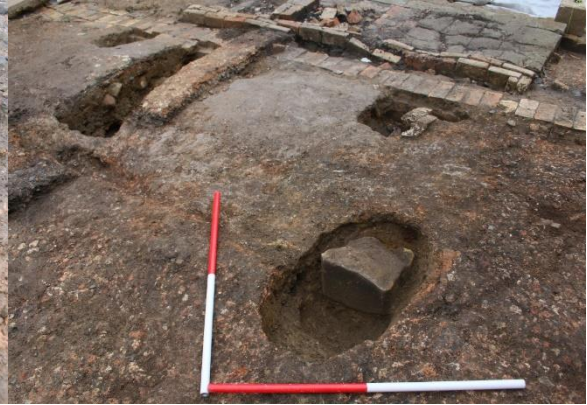
**Figure 64: West yard, posthole cut [0683] showing socket [0686] (facing east, PA2016\_01\_1430)**

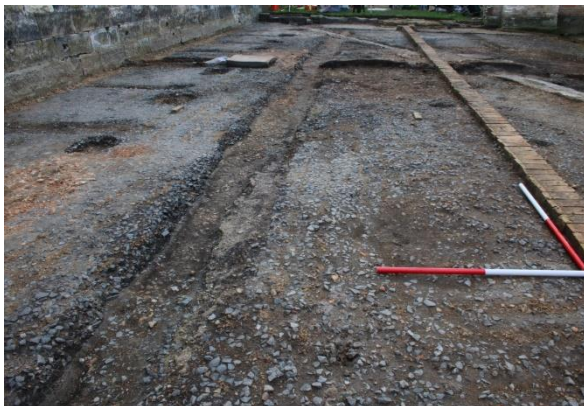
**Figure 65: West yard, showing (0081) dolerite (facing north-west, PA2016\_01\_1120)**

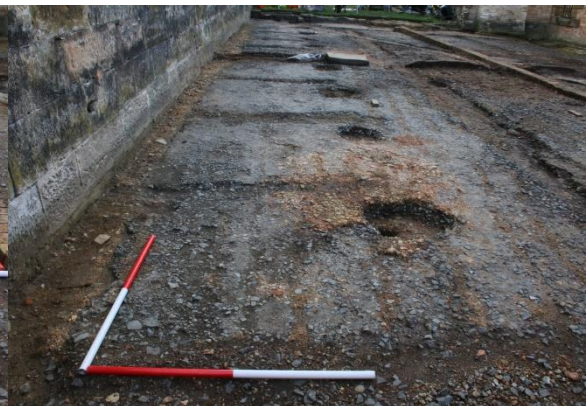
**Figure 66: West yard, showing (0081) dolerite (facing north-west, PA2016\_01\_1122)**

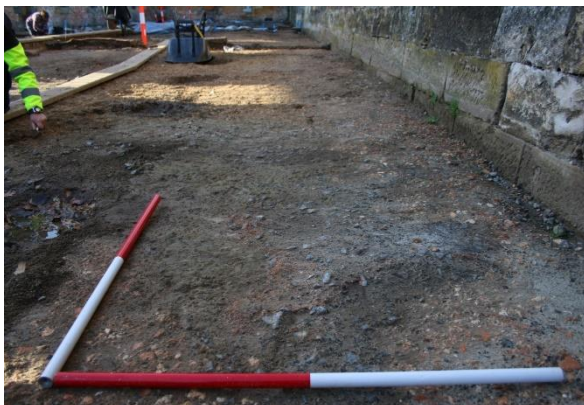
**Figure 67: West yard, showing compact (0644) at base of (0081) (facing south-east, PA2016\_01\_1305)**

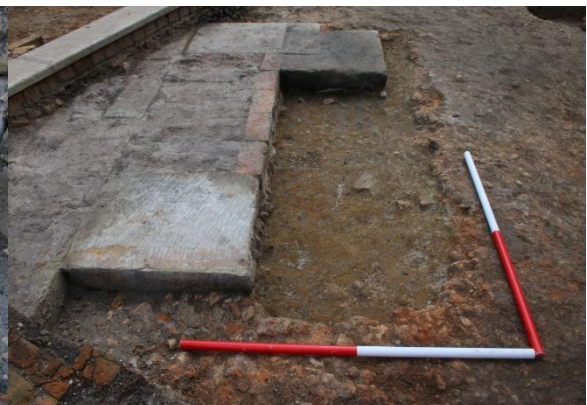
**Figure 68: West yard, feature [0636], showing modification (facing west, PA2016\_01\_1349)**

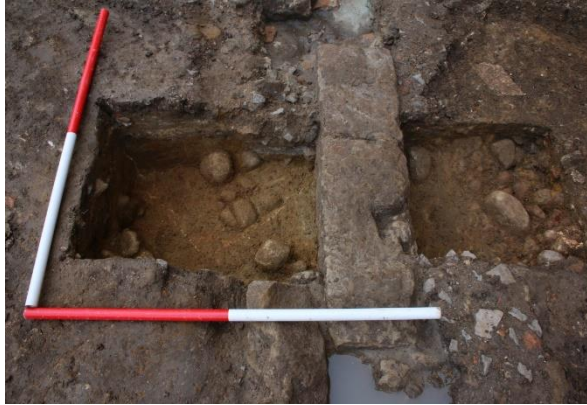
**Figure 69:** East yard, WS 3, showing depth of footing [0324] (facing north, PA2016\_01\_1539)

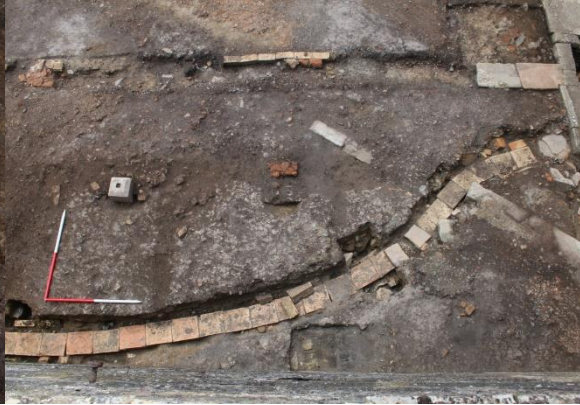
**Figure 70:** East yard, showing disturbed brick gravel to the west of [0324] (facing north-east, PA2016\_01\_0650)

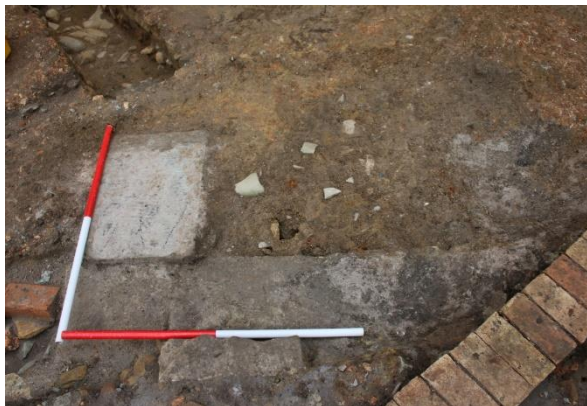
**Figure 71:** East yard, sandstone feature [0700] east of [0324] (facing east-north-east, PA2016\_01\_1513)

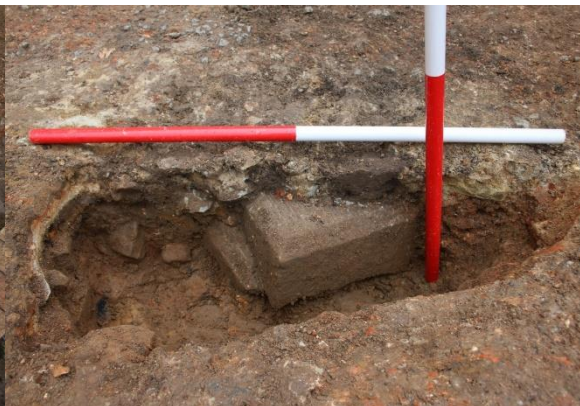
**Figure 72:** East yard, posthole cut [0688] showing socket [0692] (facing north-north-east, PA2016\_01\_1436)

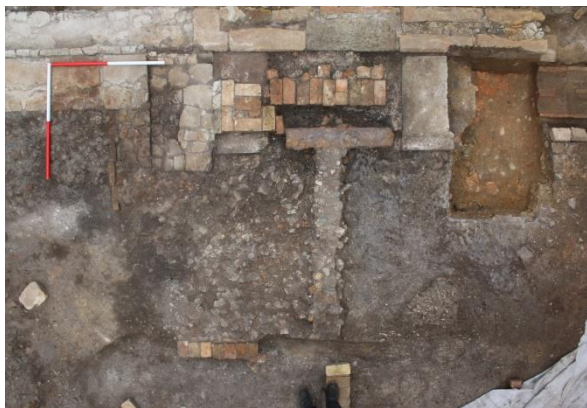
**Figure 73:** East yard, showing broken sandstone apron (0017) (facing north-west, PA2016\_01\_0730)

Abutting the eastern side of these features was a deposit of sandstone rubble (0017) (Figure 73). Up to 0.10m thick, the deposit extended up to 2.50m off the line of footing [0019] and ran from [0020] – where its edge was defined by four edge-laid bricks [0096] – as far as [0389]. It had been laid directly overlying (0356).

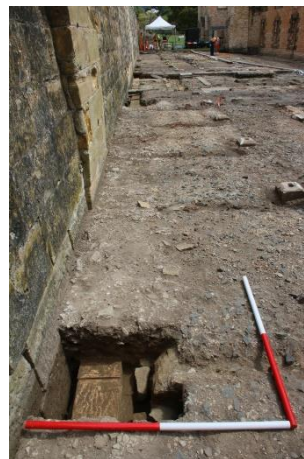
**Figure 74:** East yard, drain [0268] along base of Champ Street wall (facing north-west, PA2016\_01\_0504)

A linear cut **[0267]** had been made along the southern edge of the yard, parallel with the base of the Champ Street retaining wall and running from the modified **[0817]** section of day room footing [0019] south-east across the length of the yard (Figure 74). It had been made into silt (0356), as well as the underlying deposits (0486)/(0505)/(0567). The cut was 17.00m long and up to 0.70m wide, following the base of the wall for 12.80m, before tracing

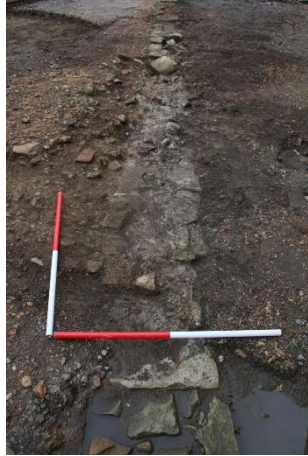
**Figure 75: West yard, showing demolition with robber cut [0327] (facing west, PA2016\_01\_1254)**

This phase resulted in the removal of footing [0326] to the level of (0332). This resulted in a cut **[0327]** into (0081) and (0332) along the line of [0326], filled with (0594)/(0639)/(0640), a mix of brick, dolerite and sandstone rubble (Figure 75). The sandstone and brick structures either side of [0326] were similarly levelled. On the north side, the courses above features [0636] and [0648] were removed **[0327]**. The patch of brick [0637] to the east of [0648] was similarly disturbed, likely when the sandstone flag mirroring [0648] was removed. The disturbance of the brick resulted in the deposition of a charcoal-rich silt (0602) over [0637], and (0597) over the adjacent (0081)/(0635), as well as the deposition of rubble deposit (0641) in the eastern extent of cut **[0645]**. The whole was capped by a compact mixed mortar and rubble deposit (0510) (Figure 76).

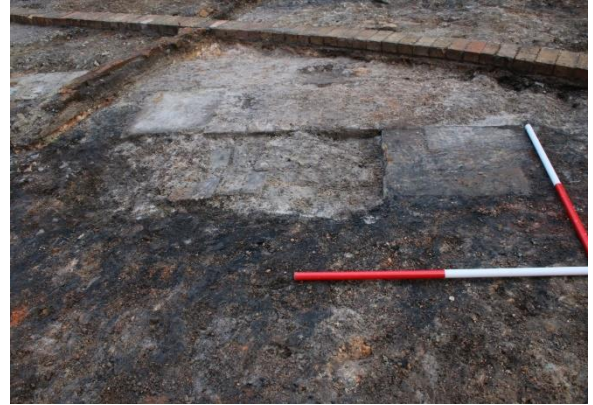
**Figure 76: West yard, mortar demolition debris and charcoal-rich deposit (0602) around northern fireplace (facing south, PA2016\_01\_1130)**

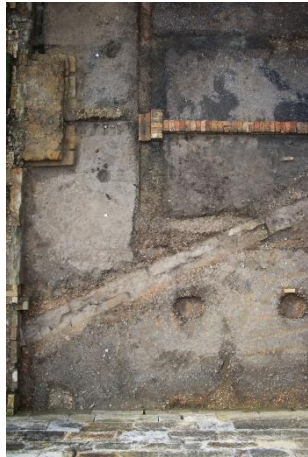
**Figure 77: West yard, compact mortar (0151) overlying (0081) (facing north-east, PA2016\_01\_1076)**

With the upstanding structures levelled, over three-quarters of the west yard was covered by a compact deposit of sandstone and siltstone gravel in a shell lime mortar (0151) (Figure 77 and Figure 78). Up to 0.10m thick, this deposit was concentrated in the western and southernmost areas of the yard, thinning toward the eastern and northern extents. As with (0081), (0151) thinned noticeably where the ground sloped downward toward the

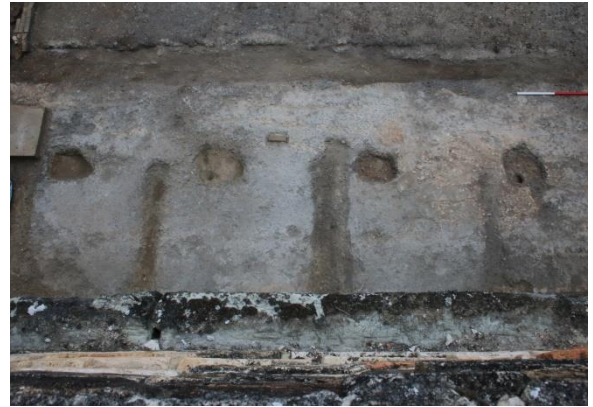
**Figure 78: West yard, compact mortar (0151) overlying (0081) (facing north-east, PA2016\_01\_0995)**

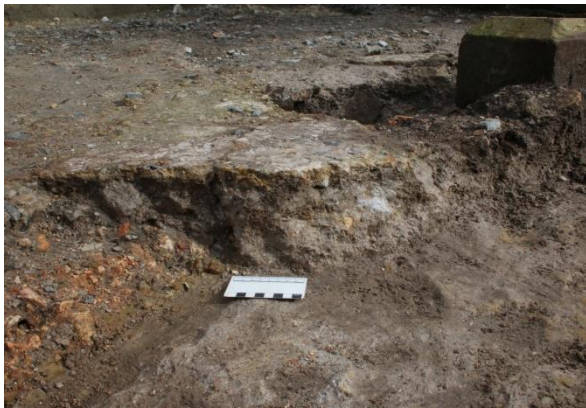
**Figure 79: West yard, thick shell lime mortar (0593) overlying [0326] footing (facing west, PA2016\_01\_1051)**

In the western extent, (0151) was situated on a very compact shell lime mortar (0592) 0.05m thick, with a similar 0.10m thick deposit of very compact mortar (0593) covering truncated footings [0326] (Figure 79). Where (0151) overlay the location of the sandstone and brick structure either side of the footing, a thin (0.01m) layer of crushed brick, sandstone and dolerite (0576) was situated below (0151). Patches of (0576) were also located to the south-east.

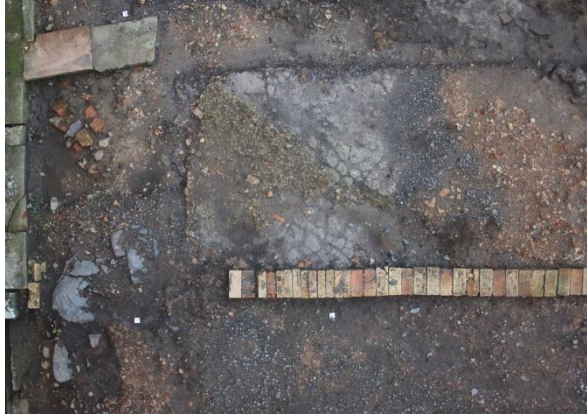
**Figure 80: West yard, striation [0591] visible in underlying (0081) dolerite (facing east, PA2016\_01\_1125)**

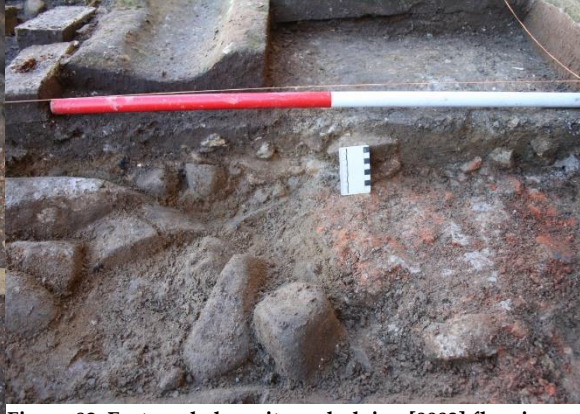
**Figure 81:** East yard, dolerite gravel (0584), shell lime mortar (0583) and siltstone gravel (0582) (facing south-west, PA2016\_01\_1403)

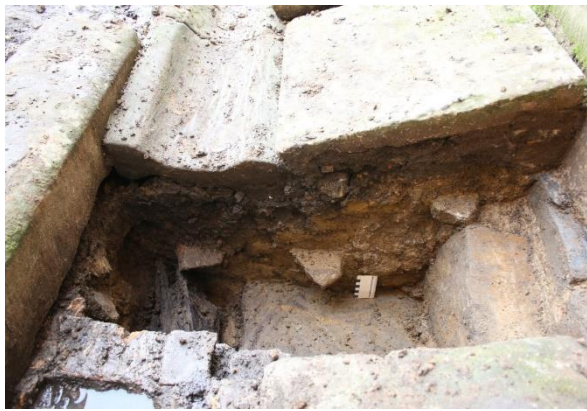
**Figure 82:** East yard, deposits underlying [0003] flagging and [0004] drainage (facing north-west, PA2016\_01\_1710)

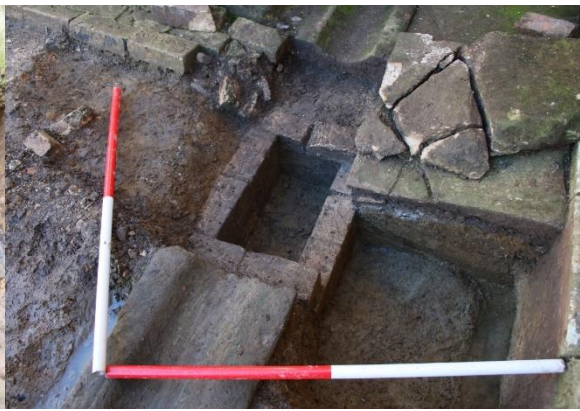
**Figure 83:** East yard, deposits underlying [0003] flagging and [0004] drainage (facing north-west, PA2016\_01\_1638)

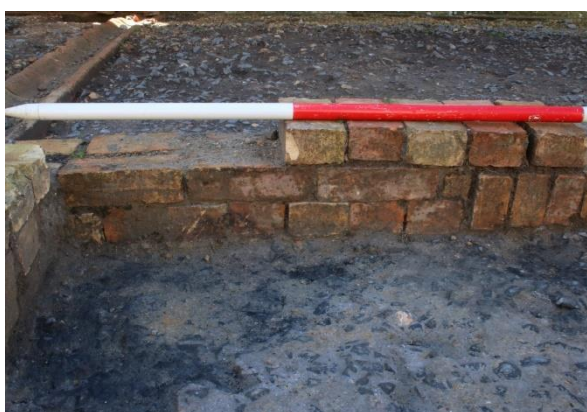
**Figure 89: Day room, mid-excavation showing removal of (0249)/(0250)/(0372) and exposure of (0064) (facing north-east, PA2016\_01\_0768)**

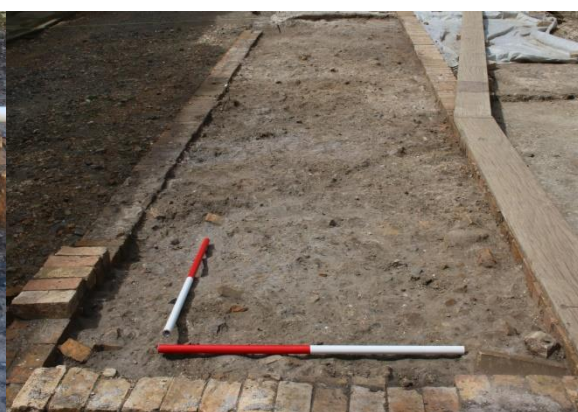
**Figure 90: West yard, footing [0138] (facing north-east, PA2016\_01\_1039)**

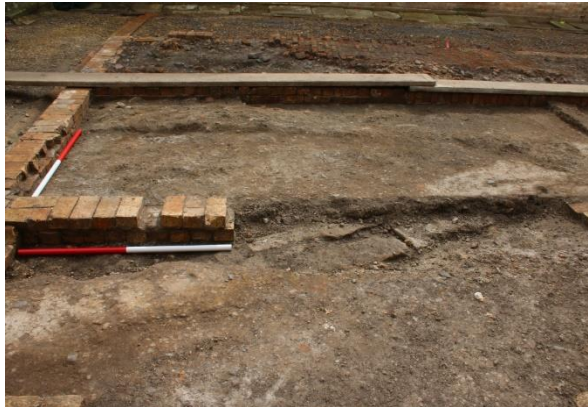
**Figure 91: West yard, showing deposit (0419) within structure's footprint (facing south-east, PA2016\_01\_0758)**

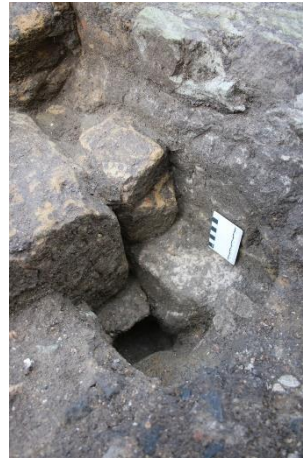
**Figure 92: West yard, showing deposit (0370) within structure's footprint (facing north-east, PA2016\_01\_0589)**

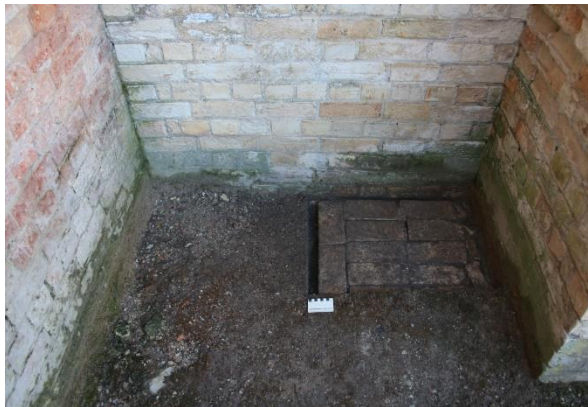
**Figure 93: West yard, showing footing [0140] (facing west, PA2016\_01\_0809)**

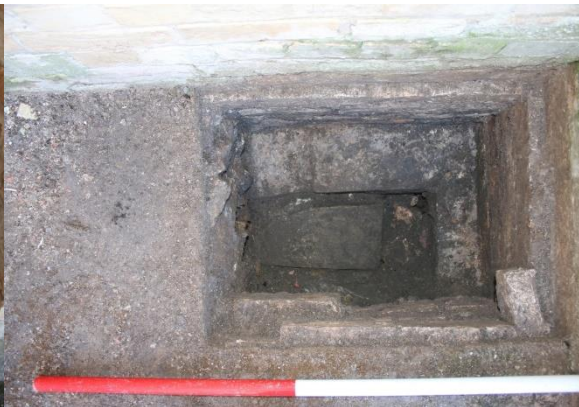
**Figure 94: Area 2 sondage, brick surface (facing south-east, PA2016\_01\_1596)**

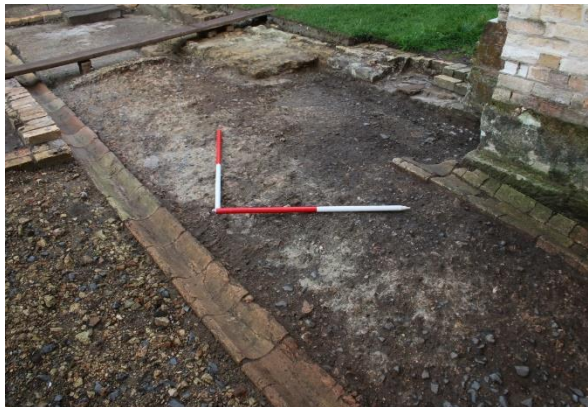
**Figure 95: Area 2 sondage, showing footing and drain at base (facing south-east, PA2016\_01\_1607)**

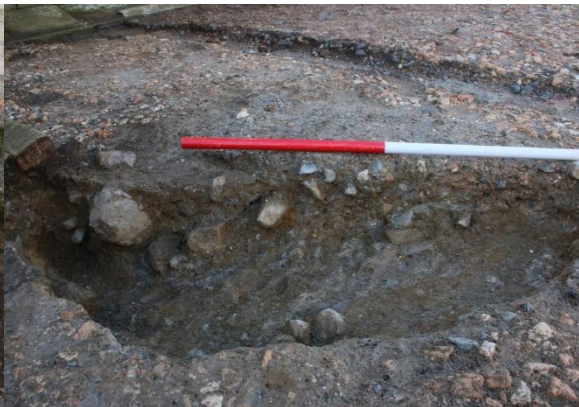
**Figure 96: West yard, levelling debris (0368) (facing west, PA2016\_01\_0779)**

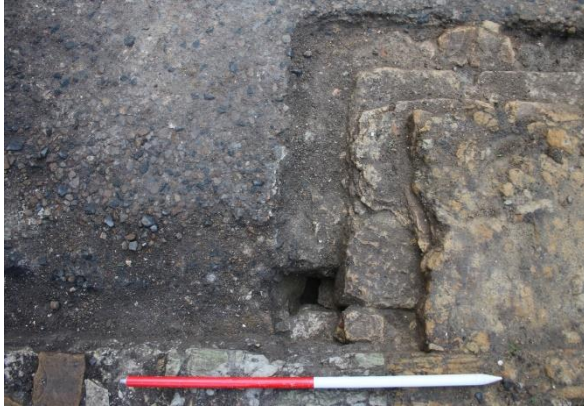
**Figure 97: West yard, pit [0668] (facing east, PA2016\_01\_1379)**

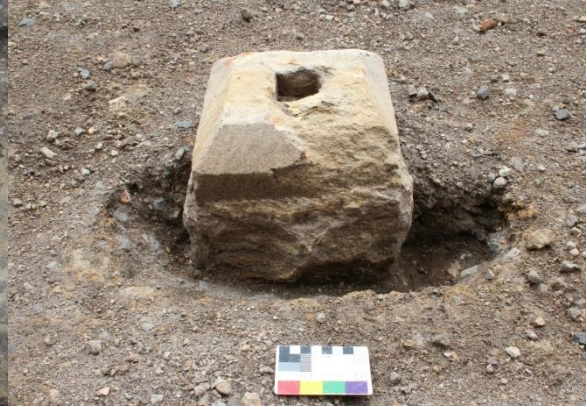
**Figure 98: West yard, showing plinth [0153] abutting footing [0140] (facing south-east, PA2016\_01\_0807)**

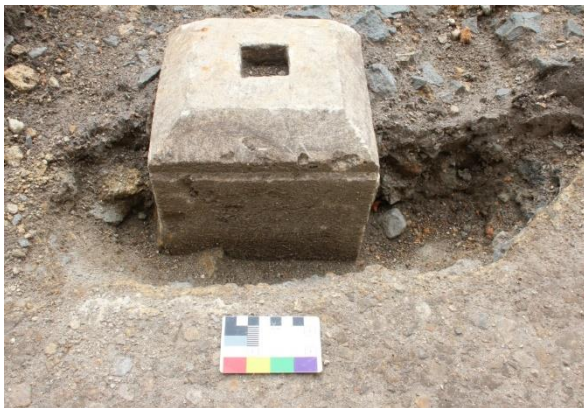
**Figure 99: West yard, socket with unfinished base (facing north-east, PA2016\_01\_0686)**

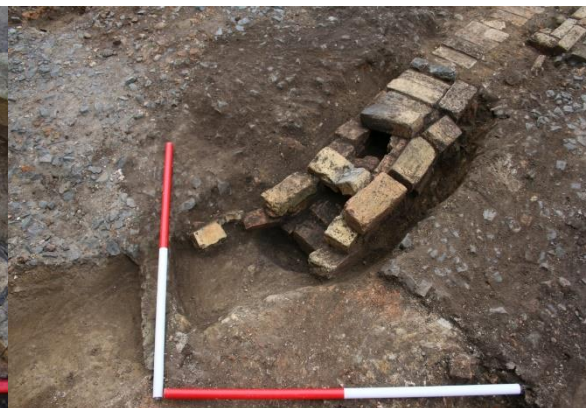
**Figure 102: West yard, section of brick box drain [0202] below flagging [0067] (facing east, PA2016\_01\_1620)**

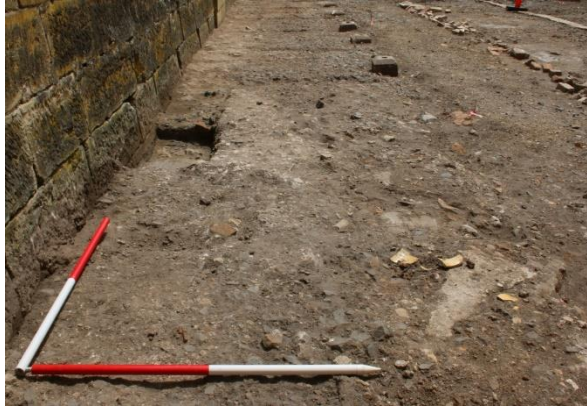
**Figure 103: West yard, modified section [0606] of brick box drain [0202] (facing north, PA2016\_01\_1178)**

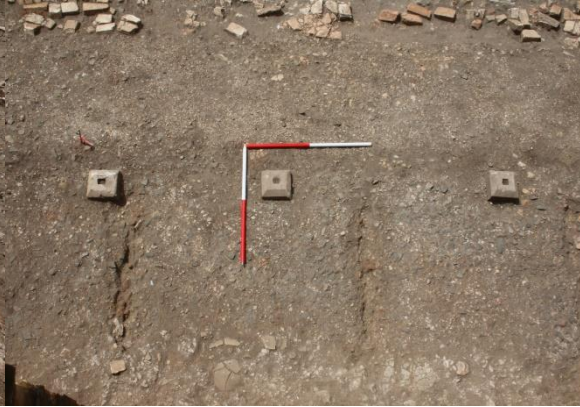
**Figure 104:** East yard, showing dolerite (0051) and topdressing (0053) (facing north-west, PA2016\_01\_0301)

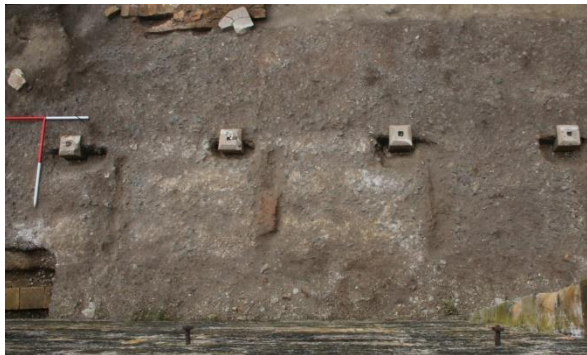
**Figure 105:** East yard, showing dolerite (0051) and topdressing (0053)/(0051) (facing north-east, PA2016\_01\_323)

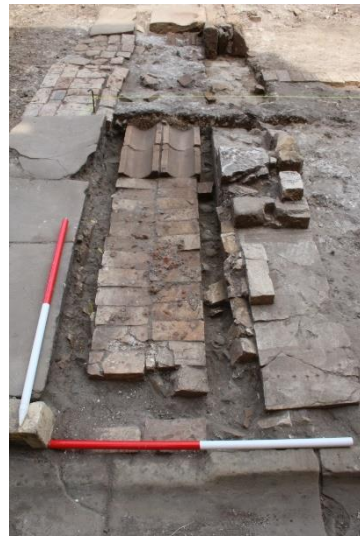
**Figure 106:** East yard, showing compacted topdressing (0403) on dolerite (0051) (facing north-east, PA2016\_01\_0708)
