# TECHNICAL REPORT

## PENITENTIARY ABLUTIONS AREA 2016 ARCHAEOLOGICAL INVESTIGATIONS

PAHSMA Archaeological Project PA2016-01

### PORT ARTHUR HISTORIC SITE, TASMANIA

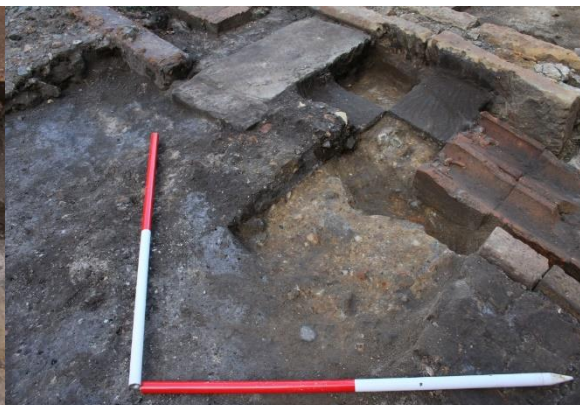
**Figure 108:** East yard, detail of drain [0164] showing *in situ* nails (facing south-east, PA2016\_01\_0437)

A linear feature comprising [0012], and [0163] – [0165] was constructed immediately adjacent to the exterior of day room footing [0019], running from flag [0389] to drain [0004] (Figure 107). A cut [0421] had been made into (0043) and the underlying clay up to 1.50m off the line of [0019]. The cut had been partly filled with clay silt and rubble (0420). This had in turn been cut by [0386], within which had been placed two brick tile spoon drains [0163]/[0164] abutting and running parallel with each other, as well as a surface of flat-laid bricks [0165]. The latter feature was 1.55m long, abutting drain [0004] at its northern end and spoon drains [0163]/[0164] at its southern. Both the brick surface and drains had a 0.05 – 0.10m gap between the features and the surrounding fabric. These were filled with a friable silt (0177)/(0178) containing regularly spaced *in situ* nails (Figure 108).

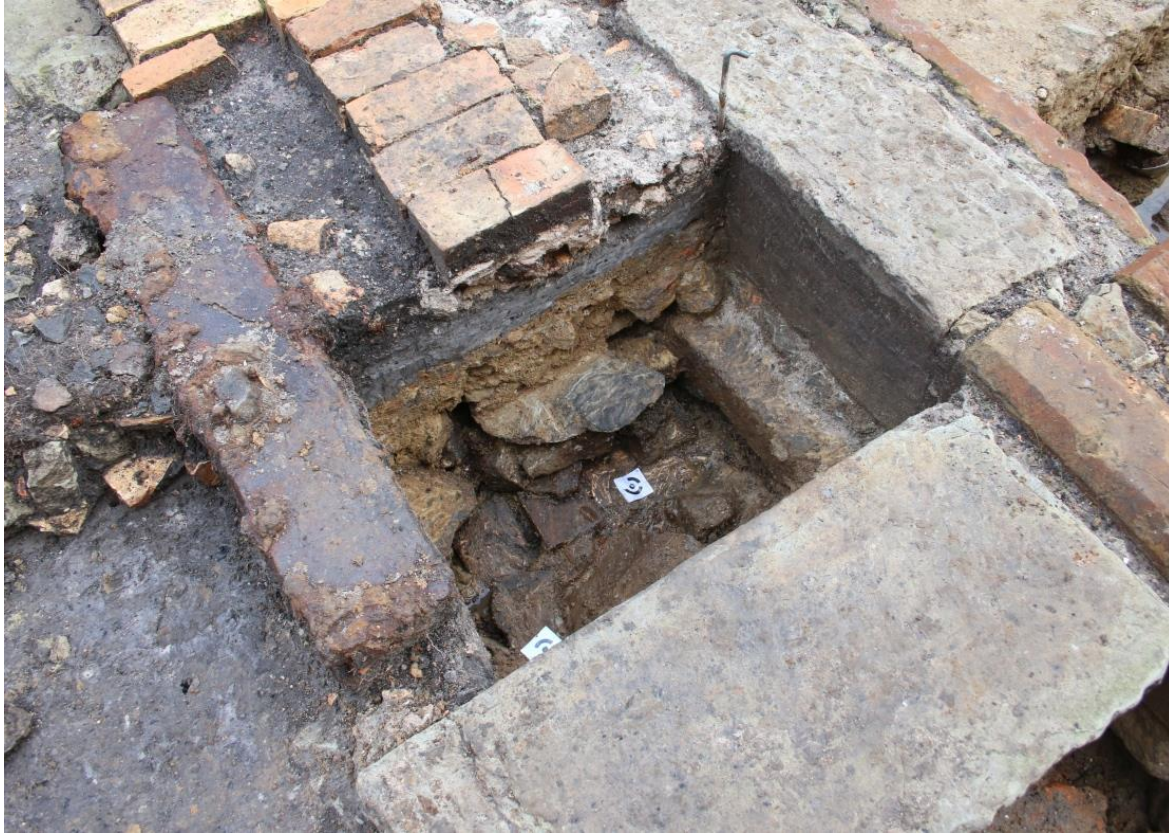
**Figure 109:** East yard, drains [0163]/[0164] after removal of [0012] (facing west, PA2016\_01\_0703)

The edge of cut [0386] had been covered by a number of features making up a hard-standing surface situated between the drain and the remainder of the east yard and set upon fill (0420). At the southern end, adjacent to [0012], were two upturned capping stones [0011] (Figure 109). Abutting them to the north was a patch of rough-laid half bricks [0255], in turn abutting a surface of bricks laid both header and stretcher-fashion [0010]. Three further upturned capping stones [0009] abutted the northern edge of [0010]. An alignment of end-laid bricks [0007] had been placed between [0009] and drain [0004], with a number of flat-laid bricks [0008] placed along the eastern edge of [0009]. Four dressed sandstone edging stones [0006] extended south-east along the southern edge of [0004], their cut [0750] made into surface (0043) and the underlying clays.

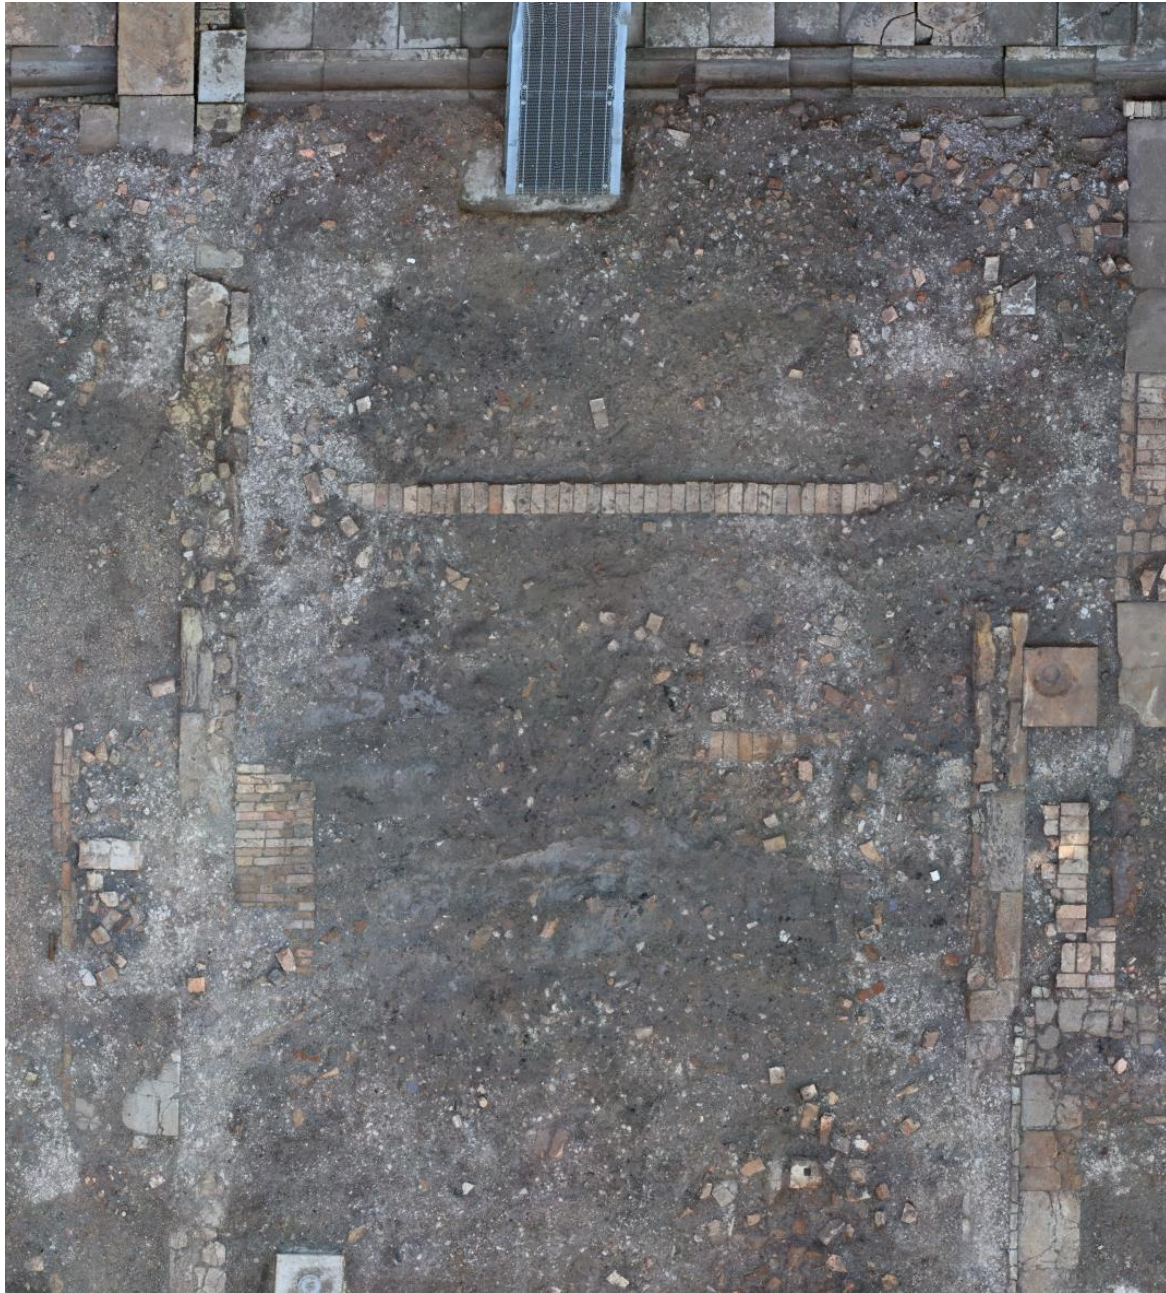
**Figure 110: East yard, iron bar [0015] (facing west, PA2016\_01\_1698)**

A number of minor features were also added to the yard during this phase. In the yard's west an iron bar [0015] was placed along the front of feature [0013]/[0014]/[0389]/[0413]. It had been excavated [0411] into (0017) and (0356), with the construction cut later covered by mixed deposit (0095) (Figure 110). In the yard's south, two circular cuts [0549]/[0551] had been made into (0356) and (0588) and were filled with a mixture of broken dolerite and brick. Both were approximately 0.40m in diameter and 0.10m deep.

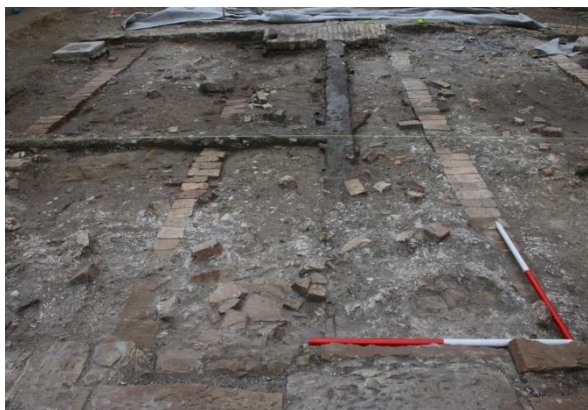
**Figure 111: Day room, showing post-abandonment deposits (facing north-east, generated orthomosaic)**

Deposits of mortar and plaster-rich silt, (0018) and (0057), up to 0.20m thick were situated over footings **[0019]** and **[0068]** (Figure 111). Deposit (0018) was located over **[0019]** for most of its length and extended part-way into the east yard and into the centre of the day room. Deposit (0057) similarly covered the full extent of **[0068]**, also extending toward the day room's centre and covering elements within the west yard. Both demolition deposits draped over the footings and down into the day room, overlying the interface deposits of (0073), (0249) and (0250) (Figure 112). In the western extent, the demolition deposits covered rubble and charcoal lenses located in association with brick feature **[0070]**. Deposit (0183) comprised up to 0.05m of a fine, charcoal-infused silt, overlain by (0139), a mortar and rubble-rich deposit up to 0.15m thick. No commensurate deposit was located on the other side of the day room, in association with (0195). In the south-eastern extent of the day room a mixed silty deposit, (0378), 0.05m – 0.10m thick with a large amount of brick rubble was located below (0372).

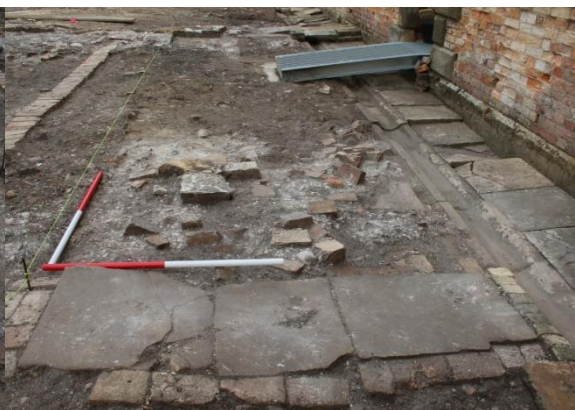
**Figure 112: Day room, showing demolition debris (0018) and (0057) with the darker silt accrued in the middle of the day room (facing north-west, PA2016\_01\_0439)**

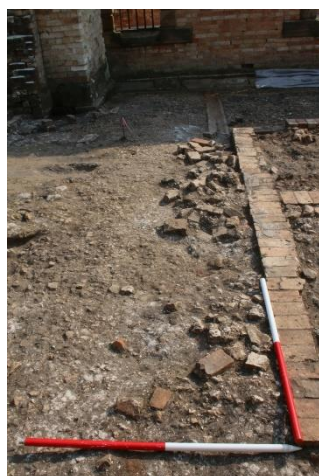
**Figure 113: Day room, showing demolition debris at north end of space (facing north-west, PA2016\_01\_0296)**

In the space between footing **[0161]** and spoon drain **[0004]**, the clay and rubble of (0311) and silt (0253) was overlain by sandy silt (0172), which was in turn covered by clay silt (0167) and clay silt with brick inclusions (0166). This was covered by a dark clay silt (0137) 0.04m thick, directly underlying the mortar and rubble-rich overburden of (0018) and (0057). All these layers, including the overlying topsoil (0001), had been cut - **[0062]** - by the installation of the concrete pad for the modern walkway **[0063]** (Figure 113).

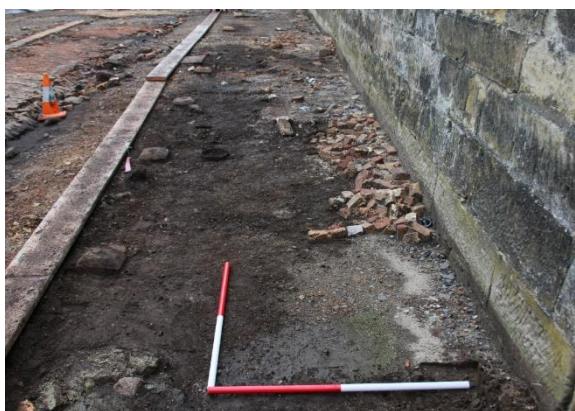
**Figure 114: West yard, demolition debris (0135) (facing north-east, PA2016\_01\_0384)**

The superstructure and sections of the brick footings of the central structure (defined by cut [0077] and *in situ* footings [0085]/[0094]/[0136]/[0138]/[0152]) were also removed [0821]. The removal of these footings resulted in the deposition of rubble deposits (0114) and (0135) in and around the original construction trench (Figure 114). The brick surfaces [0105] and [0112] were also disturbed, with the patches of brick rubble (0106) and (0113) deposited around the *in situ* surfacing. The disturbance to the surfacing also resulted in commensurate disturbance to the levelling and bedding deposits below. These remained *in situ* in the western half of the structure's footprint as (0109) and (0110). They were, however, less in evidence in the eastern half, though mixed deposit (0423) was likely a result of this disturbance.

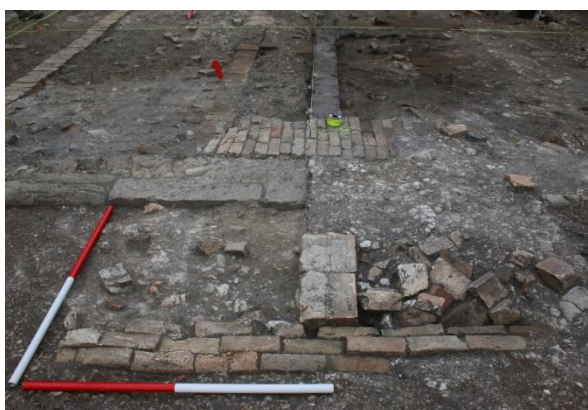
**Figure 115: West yard, demolition debris (0200)/(0201) (facing south-east, PA2016\_01\_0459)**

Along the southern edge of the area, rubble deposits (0200) and (0201) had accrued along the base of the Champ Street retaining wall (Figure 115). These overlay surface (0151), as well as the series of linear cuts and cut [0230].

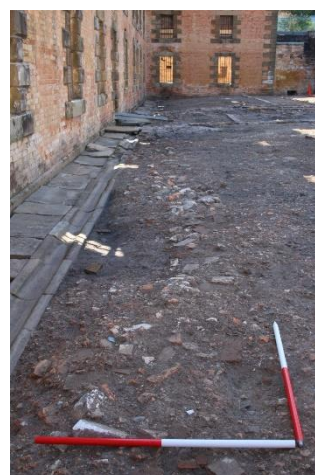
**Figure 116: West yard, demolition debris over eastern fireplace (facing south-east, PA2016\_01\_0345)**

In the east extent of the yard, brick and mortar debris (0698) and (0078) capped the brick and sandstone features [0080], [0568], [0569] and [0570], also filling the voids between the brick alignments (Figure 116). Mortar and plaster debris (0057) from the day room also covered these deposits.

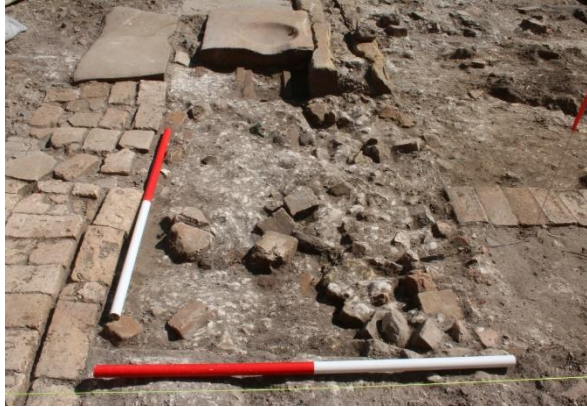
**Figure 117: West yard, demolition debris (0102) (facing south-east, PA2016\_01\_0271)**

In the northern extent of the west yard, surfacing deposit (0091) was quite mixed, suggesting it had been affected by the post-abandonment salvage activity. An extensive lens of rubble (0102) was also situated along the very northern edge of the yard, where it abutted drain [0004] (Figure 117).

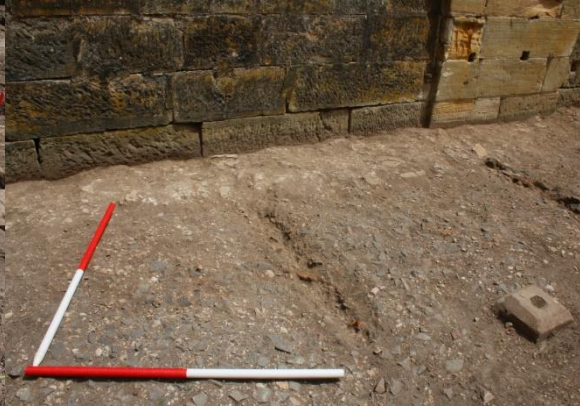
**Figure 118: East yard, demolition debris over drains (0163)/(0164) (facing south-west, PA2016\_01\_0382)**

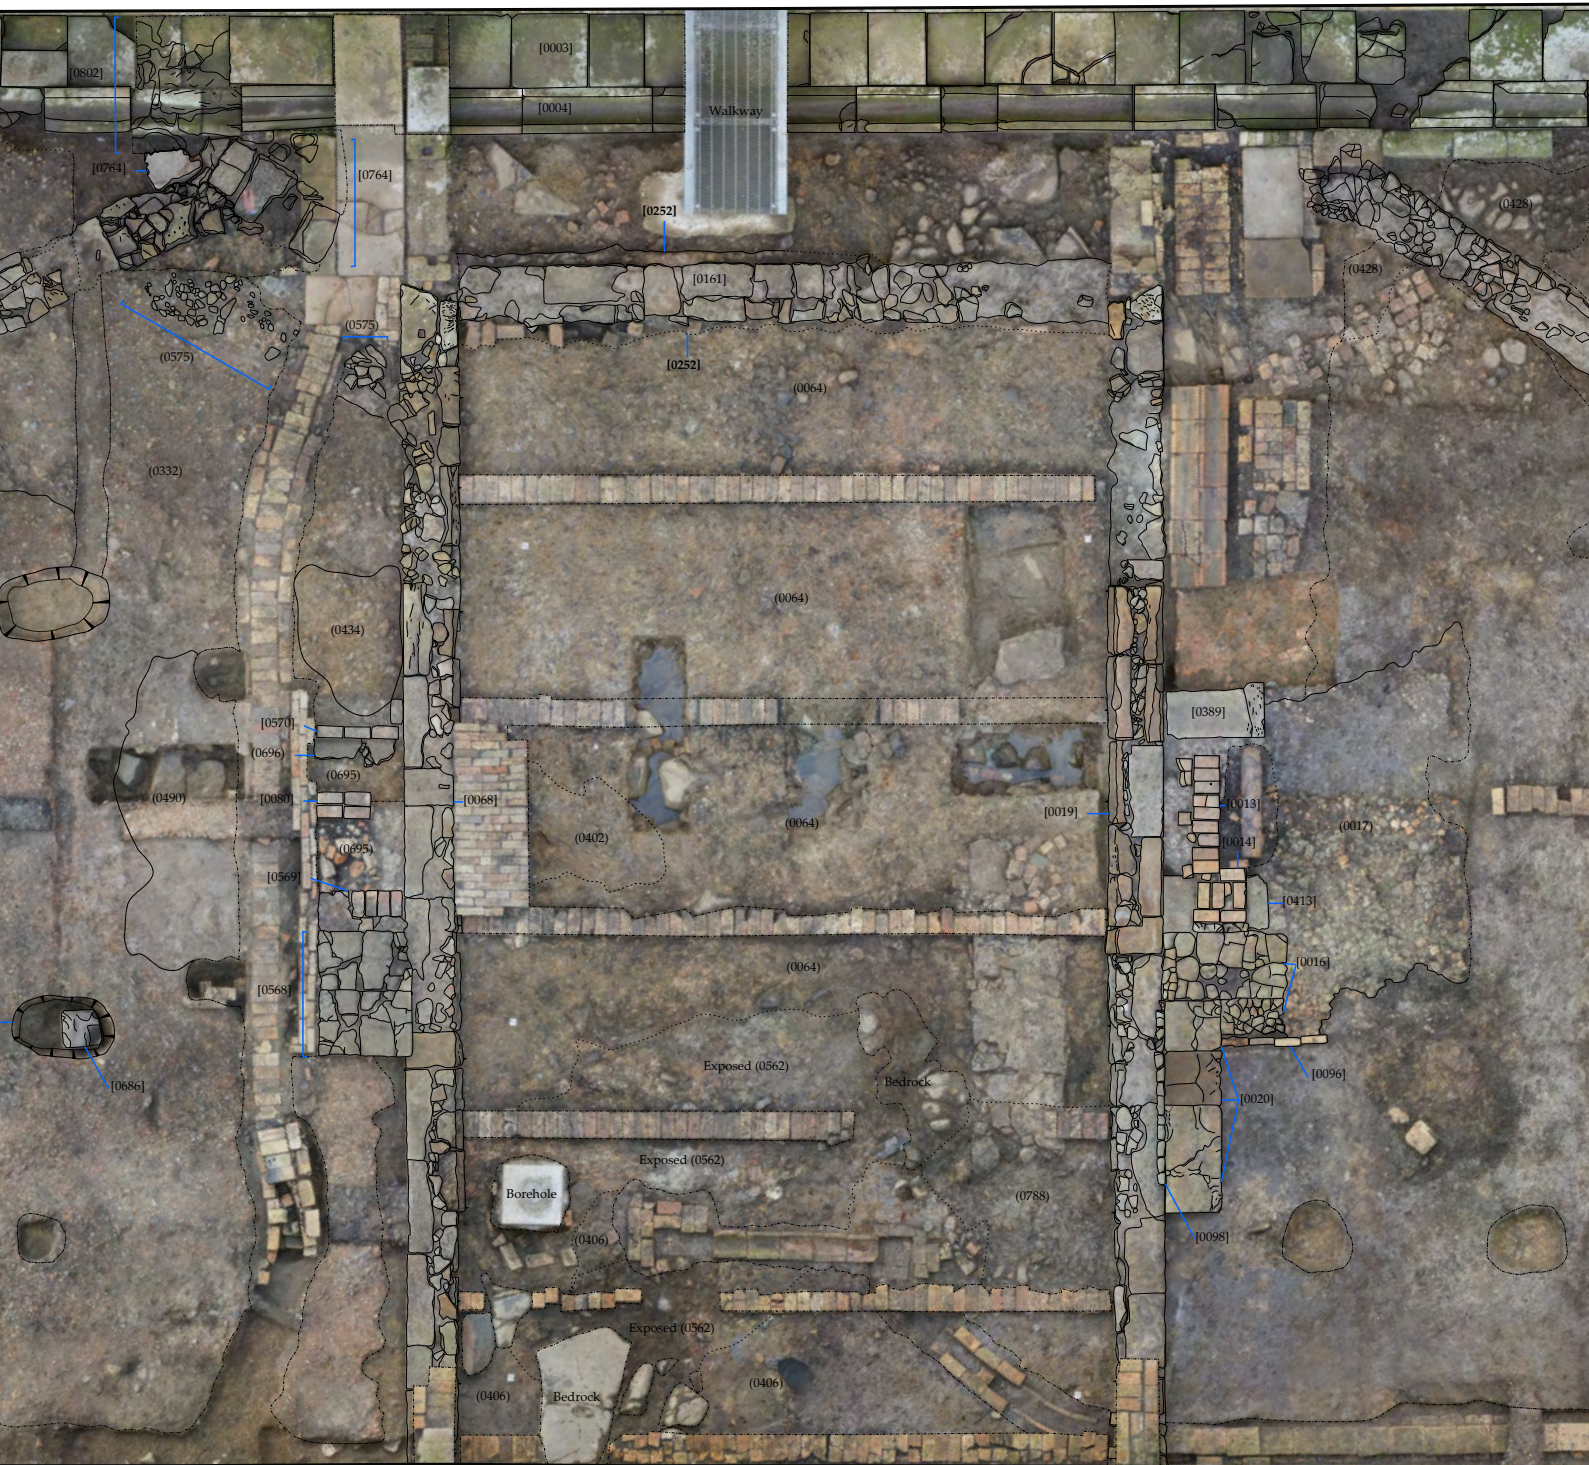
**PENITENTIARY ABLUTIONS**  
**ARCHAEOLOGICAL EXCAVATION**  
Phase I - Day room

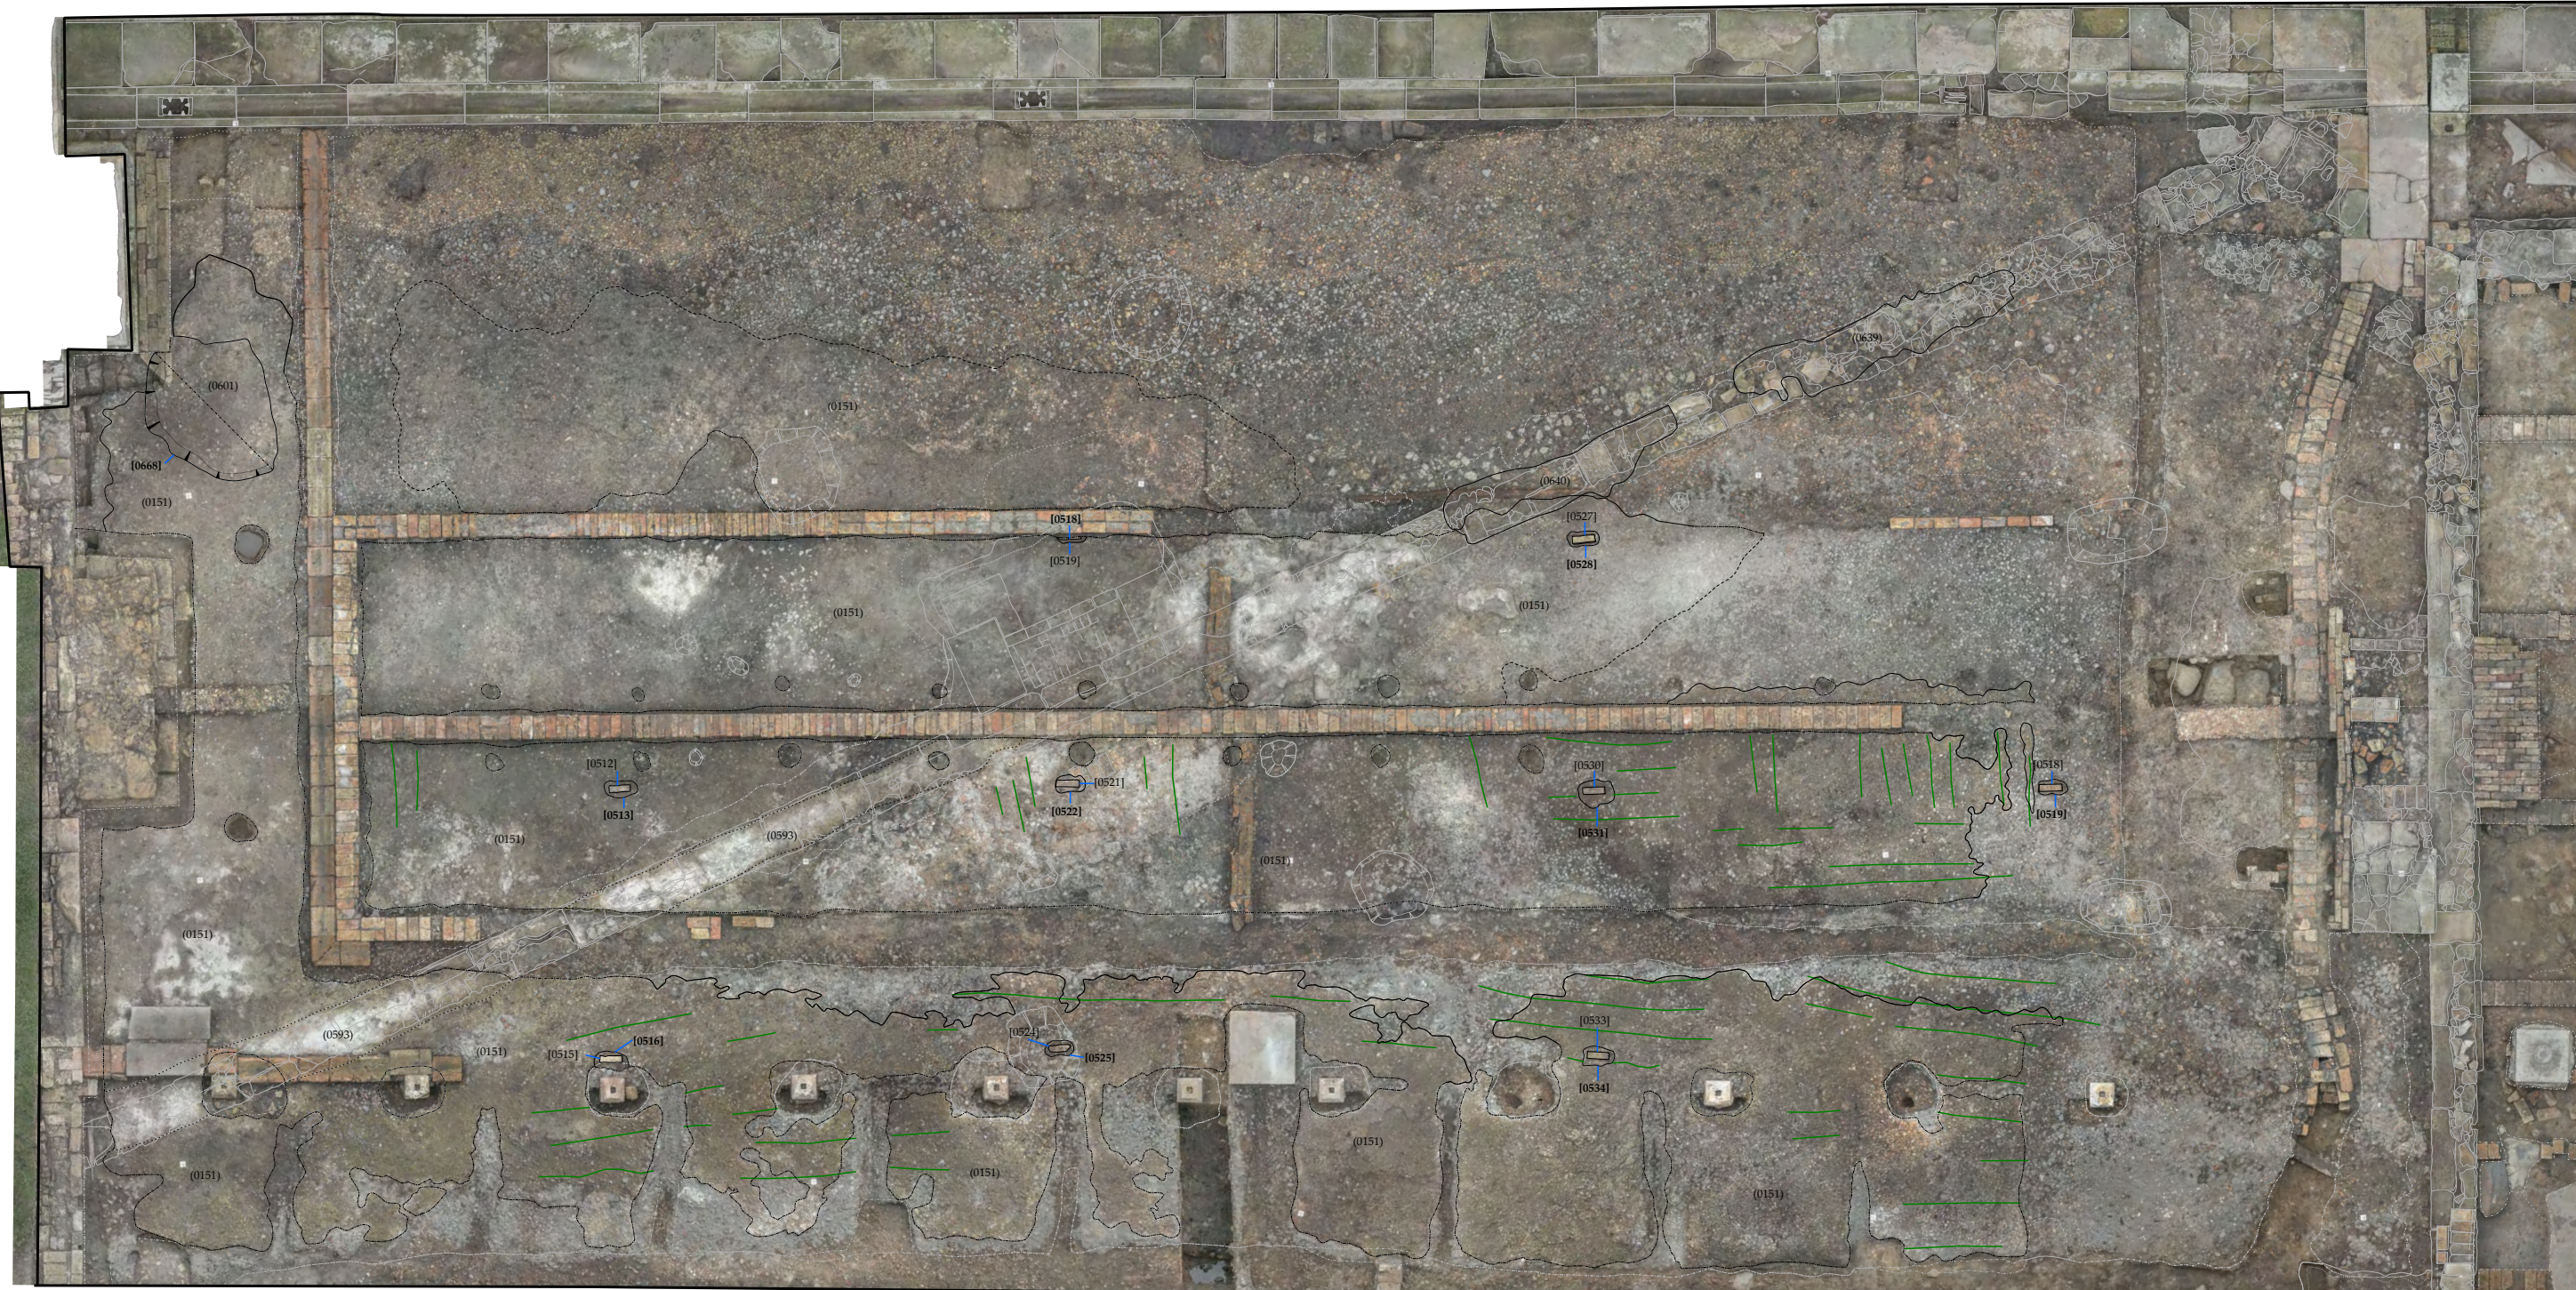
**PENITENTIARY ABLUTIONS**  
**ARCHAEOLOGICAL EXCAVATION**  
Intermediate phase - West yard

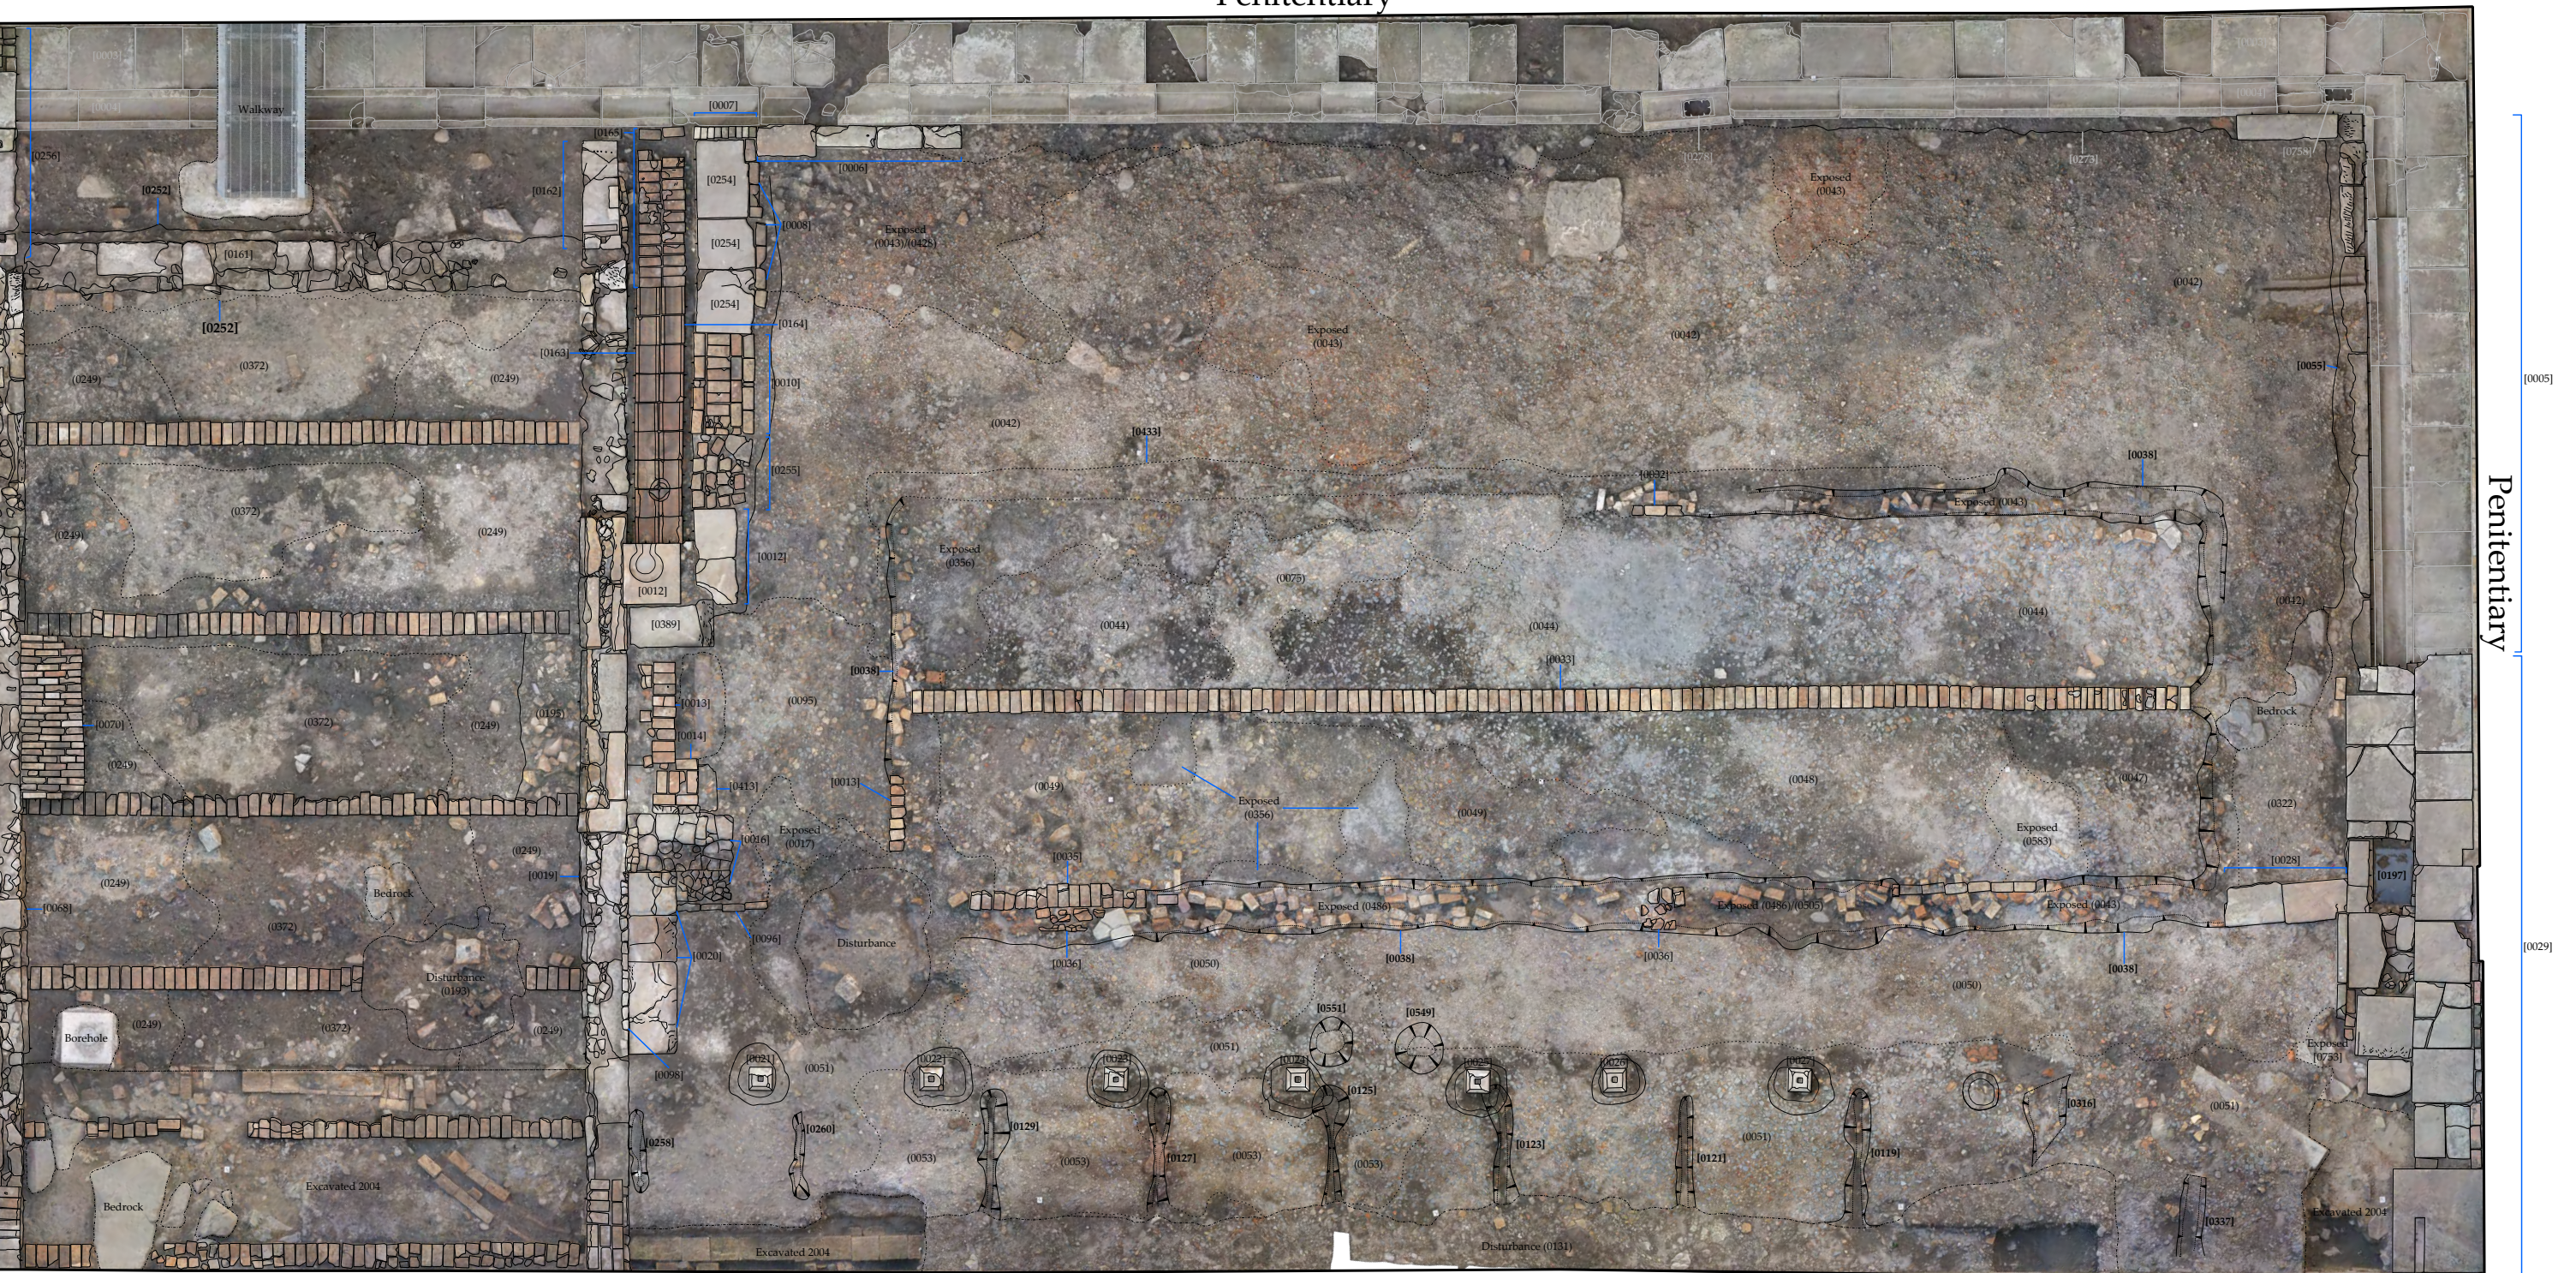
**PENITENTIARY ABLUTIONS**  
**ARCHAEOLOGICAL EXCAVATION**  
Phase II - East yard
